STM8S005xx and STM8S105xx device limitations

Silicon identification

This errata sheet applies to revision X/7 and 8 of STM8S005xx product and revisions Z, Y/6, X/7 and 8 of STM8S105xx products. A full list of root part numbers is shown in [Table 2](#).

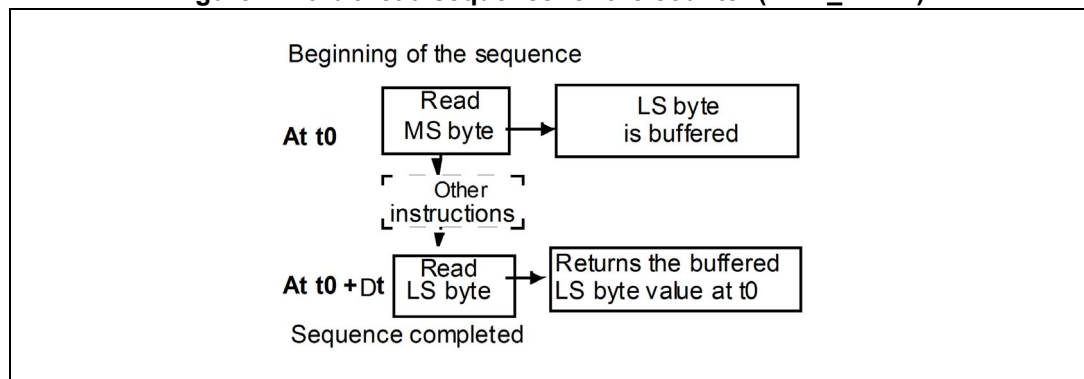
Figure 1. 16-bit read sequence for the counter (TIMx_CNTR)

An 8-bit buffer is implemented for reading the 16-bit counter registers. The software must read the MS byte first, after which the LS byte value is buffered automatically (see [Figure 1](#)). This buffered value remains unchanged until the 16-bit read sequence is completed.

When any multi-cycle instruction precedes the read of the LSB, the content of the buffer is lost and the second read returns the immediate content of the counter directly.

Do not use multi-cycle instructions before reading the LSB.
