## Device limitations for STM8AF62xx automotive MCUs featuring up to 32 Kbytes of flash program memory

### Silicon identification

This errata sheet applies to the STMicroelectronics STM8AF624x and STM8AF626x devices. The full list of root part numbers is given in [Table 2](#).

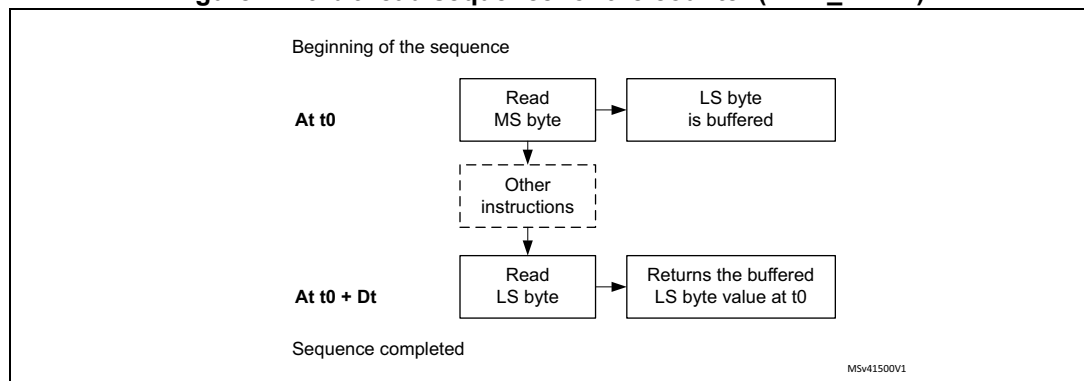
**Figure 1. 16-bit read sequence for the counter (TIMx\_CNTR)**

An 8-bit buffer is implemented for reading the 16-bit counter registers. Software must read the MS byte first, after which the LS byte value is buffered automatically (see [Figure 1](#)). This buffered value remains unchanged until the 16-bit read sequence is completed.

When any multi-cycle instruction precedes the read of the LSB, the content of the buffer is lost and the second read returns the immediate content of the counter directly.

Do not use multi-cycle instructions before reading the LSB.
