STM32F427/437 and STM32F429/439 device errata

This document applies to the part numbers of STM32F427/437 and STM32F429/439 devices and the device variants as stated in this page.

It gives a summary and a description of the device errata, with respect to the device datasheet and reference manual RM0090.

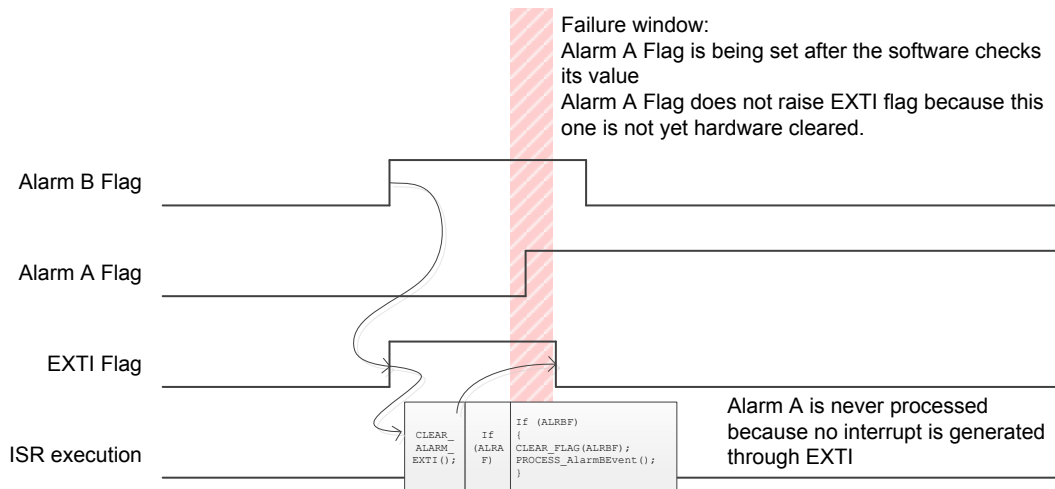
Figure 1. Masked RTC interrupt

The following code example and figure illustrate the failure mechanism: The Alarm A event is lost (fails to generate interrupt) as it occurs in the failure window, that is, after checking the Alarm A event flag but before the effective clear of the EXTI interrupt flag by hardware. The effective clear of the EXTI interrupt flag is delayed with respect to the software instruction to clear it.
