### Device limitations for STM8AF62xx automotive MCUs featuring up to 8 Kbytes of flash program memory

This errata sheet applies to the STMicroelectronics STM8AF6213 and STM8AF6223/26 devices.

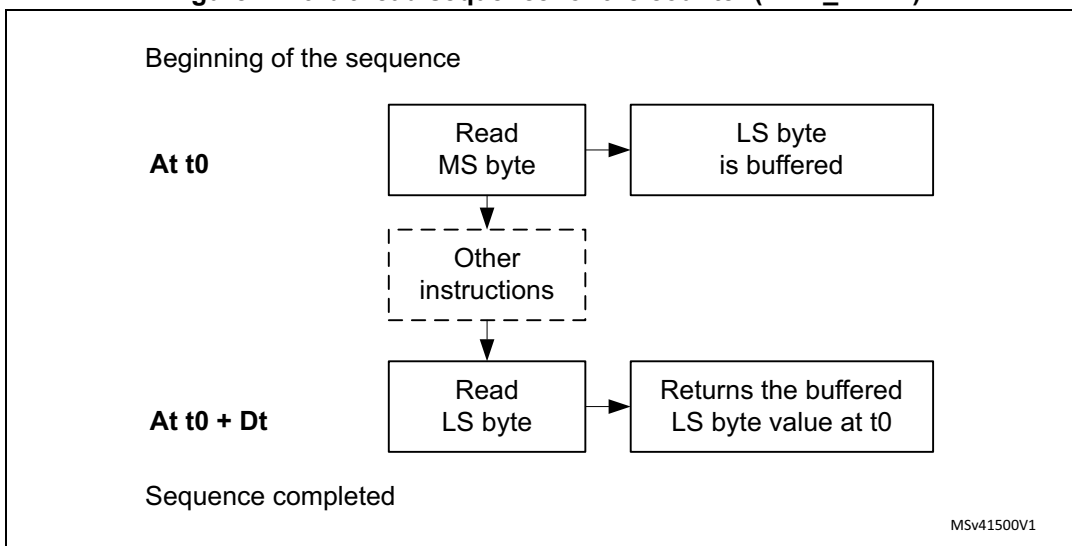
**Figure 1. 16-bit read sequence for the counter (TIMx\_CNTR)**

An 8-bit buffer is implemented for reading the 16-bit counter registers. Software must read the MS byte first, after which the LS byte value is buffered automatically (see [Figure 1](#)). This buffered value remains unchanged until the 16-bit read sequence is completed.

When any multi-cycle instruction precedes the read of the LSB, the content of the buffer is lost and the second read returns the immediate content of the counter directly.

Do not use multi-cycle instructions before reading the LSB.
