STM32F401xB and STM32F401xC device errata

This document applies to the part numbers of STM32F401xB/xC devices and the device variants as stated in this page. It gives a summary and a description of the device errata, with respect to the device datasheet and reference manual RM0368. Deviation of the real device behavior from the intended device behavior is considered to be a device limitation. Deviation of the description in the reference manual or the datasheet from the intended device behavior is considered to be a documentation erratum. The term “*errata*” applies both to limitations and documentation errata.

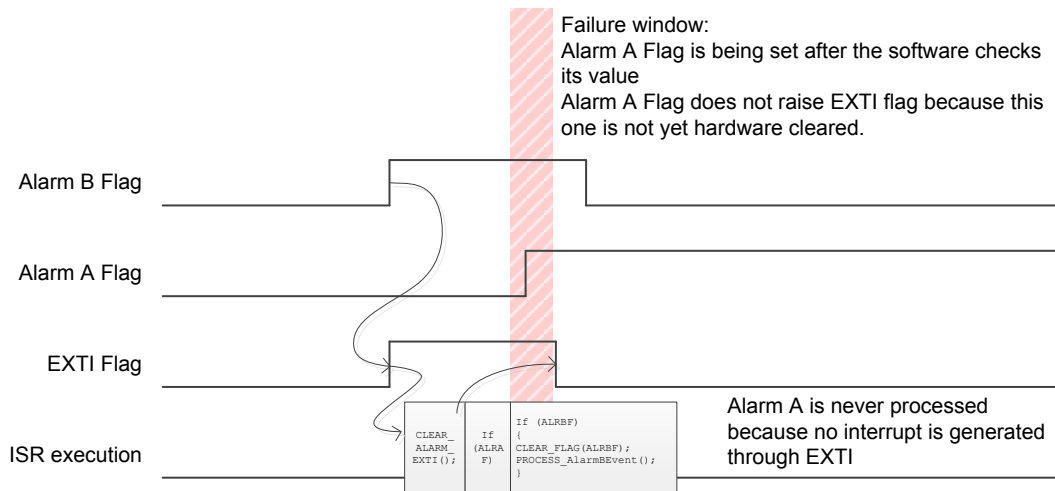
Figure 1. Masked RTC interrupt

The following code example and figure illustrate the failure mechanism: The Alarm A event is lost (fails to generate interrupt) as it occurs in the failure window, that is, after checking the Alarm A event flag but before the effective clear of the EXTI interrupt flag by hardware. The effective clear of the EXTI interrupt flag is delayed with respect to the software instruction to clear it.
