## STM32F031x4/x6 device errata

This document applies to the part numbers of STM32F031x4/x6 devices and the device variants as stated in this page.

It gives a summary and a description of the device errata, with respect to the device datasheet and reference manual RM0091.

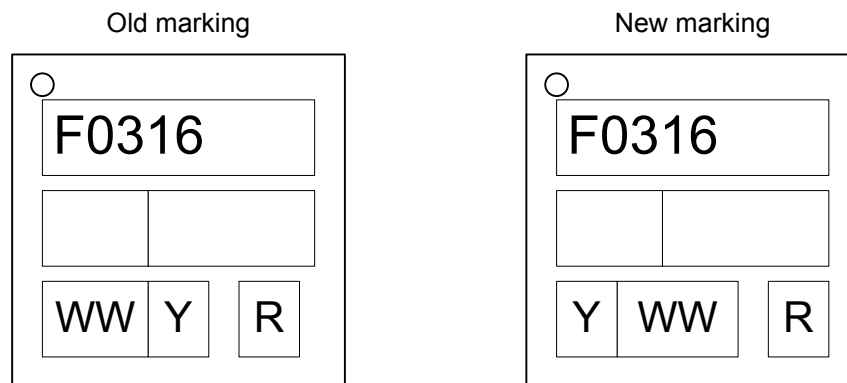
Figure 1. WLCSP25 package marking

Until week 9 of 2017, the date code on the WLCSP25 package was marked in the format WWY (two digits for week followed by one digit for year), while the figure giving the example of package marking in the product datasheet was showing the inversed sequence YWW.

From week 9, 2017 on, the marking on the WLCSP25 package is modified to show the date in the format YWW. The following figure illustrates the difference between the old and the new product marking. The figure in the product datasheet was also updated to better reflect the dimensions and layout of the marking on the package.
