STM32L15xxE STM32L15xVD-X STM32L162xE STM32L162xVD-X device errata

This document applies to the part numbers of STM32L15xxE STM32L15xVD-X STM32L162xE STM32L162xVD-X devices and the device variants as stated in this page.

It gives a summary and a description of the device errata, with respect to the device datasheet and reference manual RM0038.

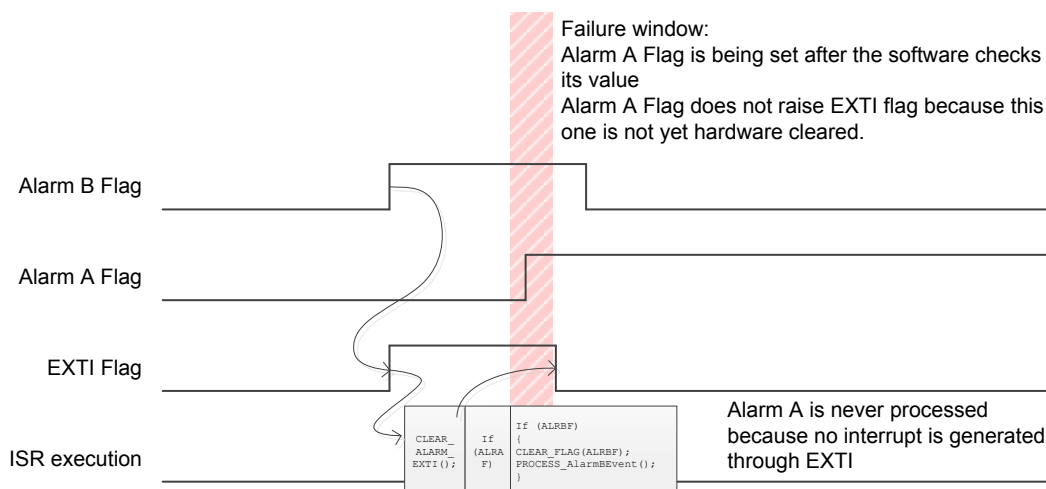
Figure 1. Masked RTC interrupt

The following code example and figure illustrate the failure mechanism: The Alarm A event is lost (fails to generate interrupt) as it occurs in the failure window, that is, after checking the Alarm A event flag but before the effective clear of the EXTI interrupt flag by hardware. The effective clear of the EXTI interrupt flag is delayed with respect to the software instruction to clear it.

Workaround

In the interrupt service routine, apply three consecutive event flag checks - source one, source two, and source one again, as in the following code example:
