STM32L471xx/475xx/476xx/486xx device errata

This document applies to the part numbers of STM32L471xx/475xx/476xx/486xx devices and the device variants as stated in this page.

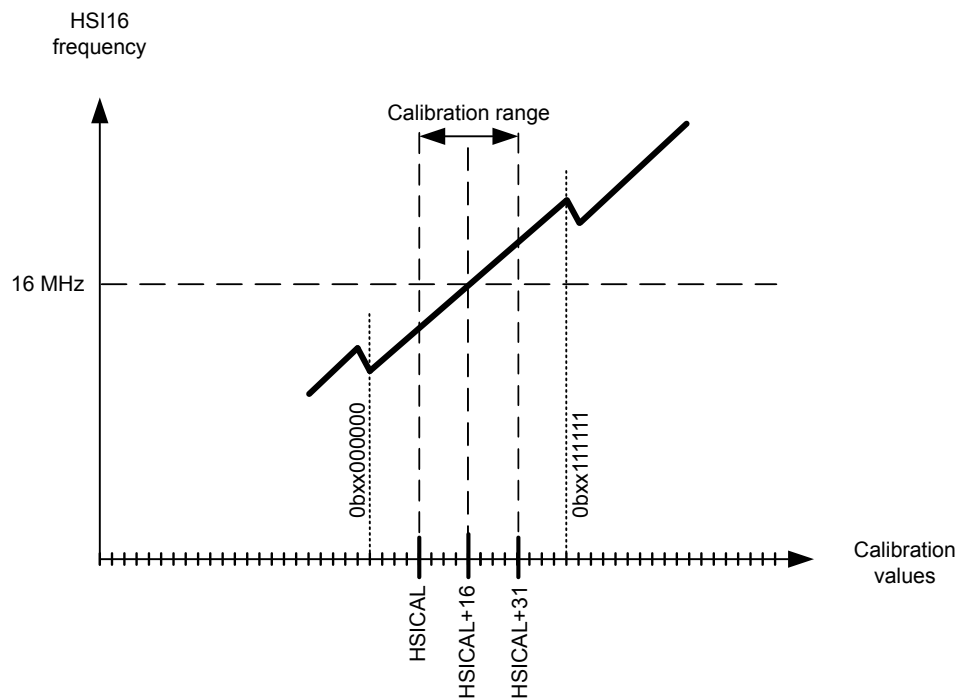
Figure 1. HSI oscillator trimming characteristics

Consequently, the user trim correction must not jump over the codes multiple of 64, which can limit the user correction either in positive or in the negative direction.

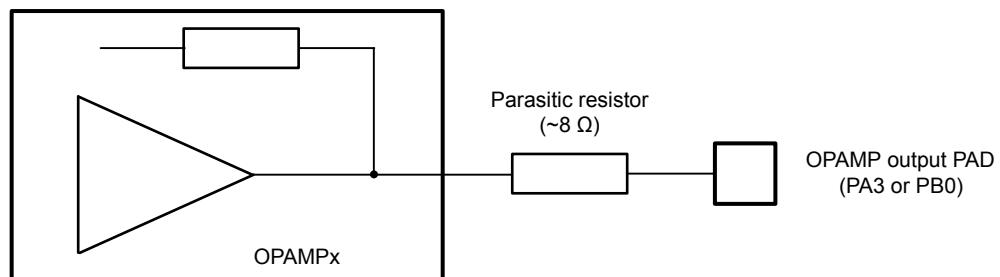
Figure 2. Parasitic resistor on OPAMP output

The value of the resistor between OPAMP outputs and I/O (PA3 or PB0) is greater than expected: 8 Ω typical, as shown in Figure 2. As a consequence, the OPAMP characteristics can be impacted depending on the current sunk on the output.

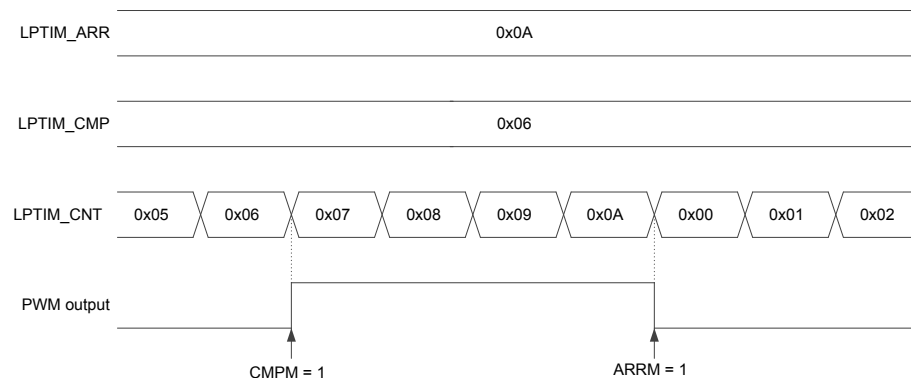
Figure 3. Example of PWM output mode

The following waveform gives the example of PWM output mode and the effect of the delay:

Set the compare value to the desired value minus 1. For instance in order to generate a compare match when LPTIM_CNT = 0x08, set the compare value to 0x07.

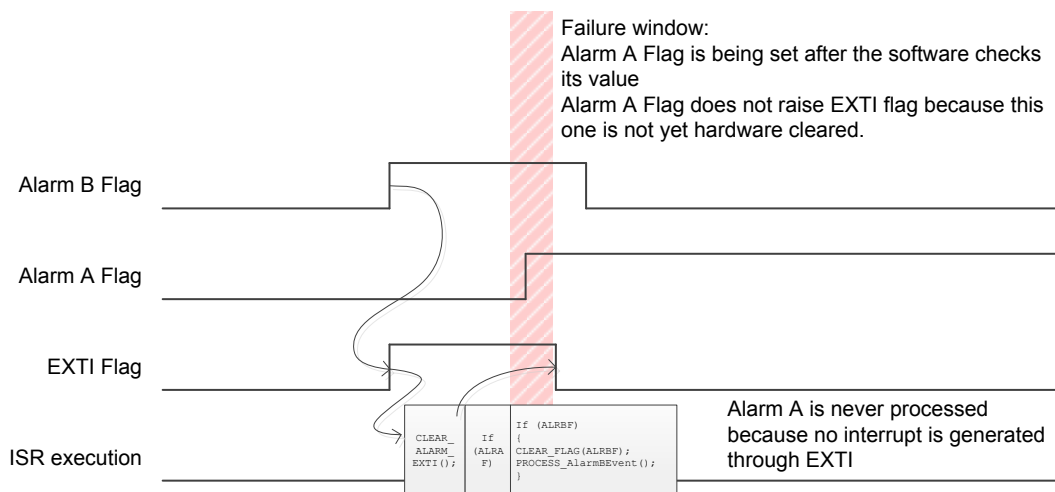
Figure 4. Masked RTC interrupt

The following code example and figure illustrate the failure mechanism: The Alarm A event is lost (fails to generate interrupt) as it occurs in the failure window, that is, after checking the Alarm A event flag but before the effective clear of the EXTI interrupt flag by hardware. The effective clear of the EXTI interrupt flag is delayed with respect to the software instruction to clear it.
