STM32F091xB/xC device errata

Applicability

This document applies to the part numbers of STM32F091xB/xC devices and the device variants as stated in this page.

It gives a summary and a description of the device errata, with respect to the device datasheet and reference manual RM0091.

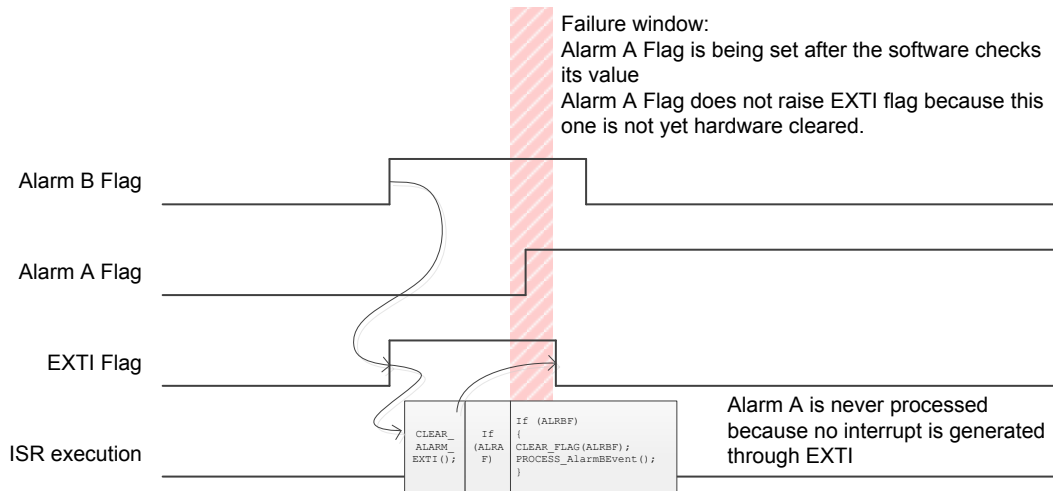
Figure 1. Masked RTC interrupt

The following code example and figure illustrate the failure mechanism: The Alarm A event is lost (fails to generate interrupt) as it occurs in the failure window, that is, after checking the Alarm A event flag but before the effective clear of the EXTI interrupt flag by hardware. The effective clear of the EXTI interrupt flag is delayed with respect to the software instruction to clear it.

Workaround

In the interrupt service routine, apply three consecutive event flag checks - source one, source two, and source one again, as in the following code example:

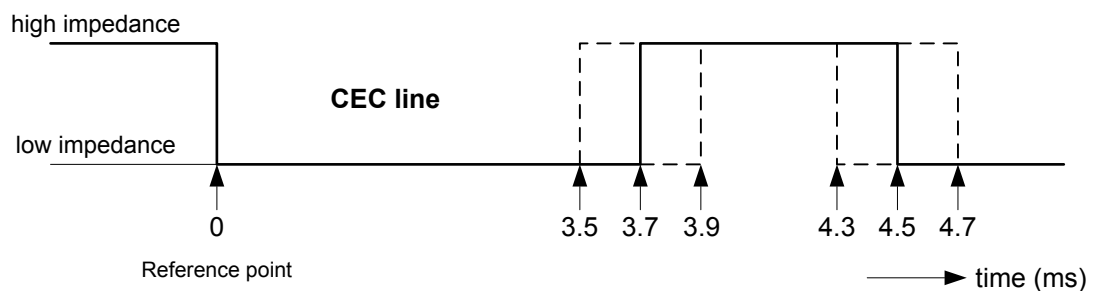
Figure 2. HDMI-CEC start bit format with tolerances

The start bit timing standard tolerances are shown in the following figure. The start bit is initiated by the device by driving the CEC line low (reference point). After 3.7 ms, the device releases the CEC line and starts checking its level. The following conditions must be met for the start bit to be valid:

If one of these conditions is not met, the transmission is aborted and never automatically retried. No error flag is set and the TXSOM (Tx start of message) bit is not cleared.

Workaround

The only way to detect this error is for the application software to start a timeout when setting the TXSOM bit, restart it upon ARBLST or any RX event (as the transmission can be delayed by interleaved reception), and stop it upon TXBR (proof that the start bit was transmitted successfully) or TXEND event, or upon any TX error (which clears TXSOM). If the timeout expires (because none of those events occurred), the application software must restart the HDMI-CEC peripheral and retransmit the message.
