STM32F098CC/RC/VC device errata

This document applies to STM32F098CC/RC/VC devices and the device variants as stated in this page.

It gives a summary and a description of the device errata, with respect to the device datasheet and reference manual RM0091.

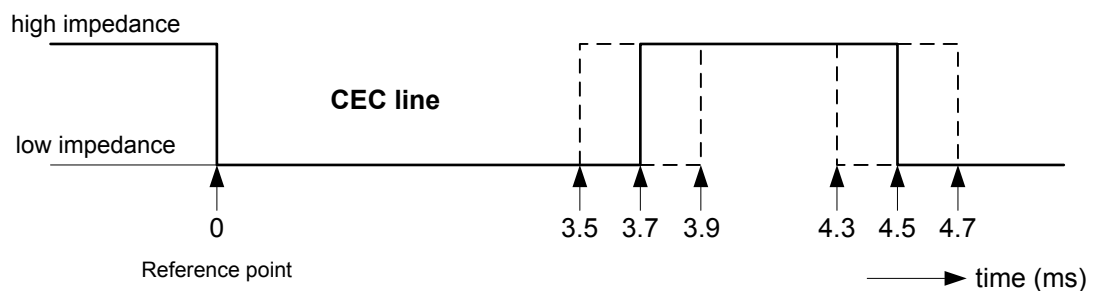
Figure 2. HDMI-CEC start bit format with tolerances

The start bit timing standard tolerances are shown in the following figure. The start bit is initiated by the device by driving the CEC line low (reference point). After 3.7 ms, the device releases the CEC line and starts checking its level. The following conditions must be met for the start bit to be valid:

If one of these conditions is not met, the transmission is aborted and never automatically retried. No error flag is set and the TXSOM (Tx start of message) bit is not cleared.

The only way to detect this error is for the application software to start a timeout when setting the TXSOM bit, restart it upon ARBLST or any RX event (as the transmission can be delayed by interleaved reception), and stop it upon TXBR (proof that the start bit was transmitted successfully) or TXEND event, or upon any TX error (which clears TXSOM). If the timeout expires (because none of those events occurred), the application software must restart the HDMI-CEC peripheral and retransmit the message.
