Applicability

This document applies to the part numbers of STM32L475xx devices and the device variants as stated in this page.

It gives a summary and a description of the device errata, with respect to the device datasheet and reference manual RM0351.

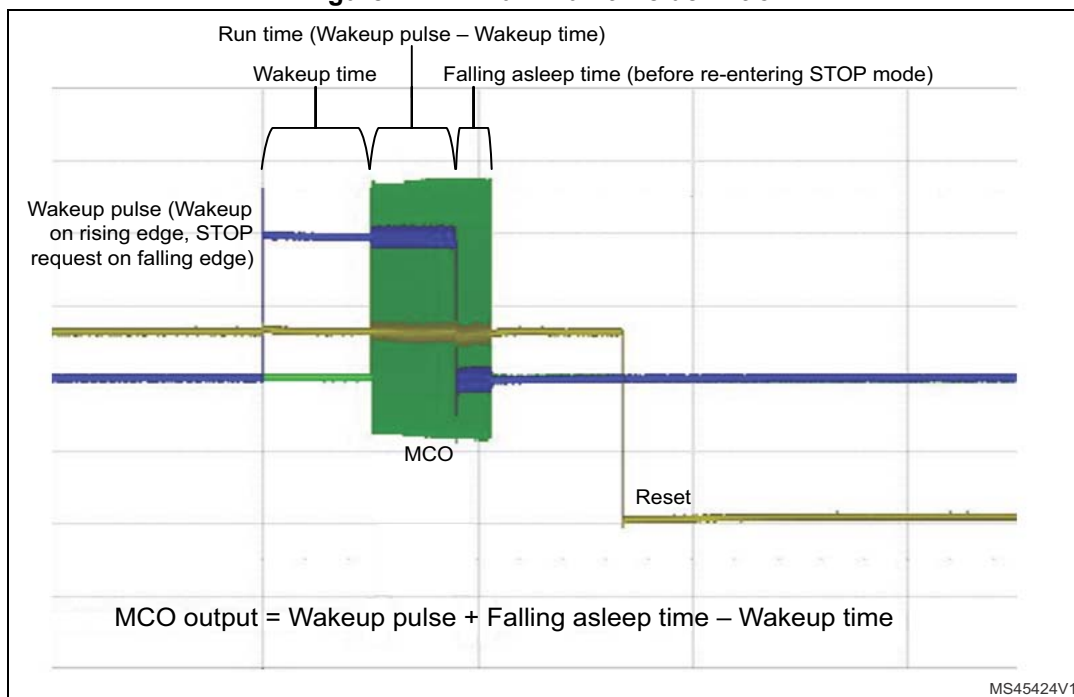
Figure 2. Minimum Run time definition

The minimum Run time defined in [Table 4](#) corresponds to the firmware execution time on the core. Note also that, as shown in [Figure 2](#), the length of the MCO output (green trace) is longer than the firmware execution time.

Ensure that the Run time between two Stop sequences is long enough to avoid the generation of a Brown Out Reset.

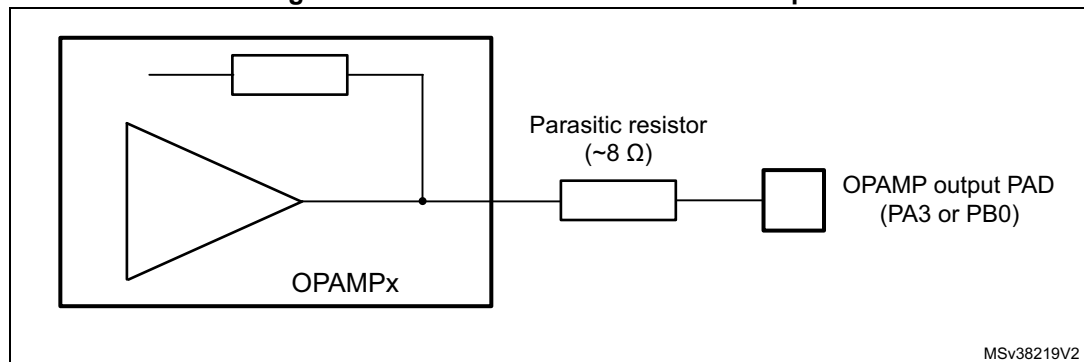
Figure 3. Parasitic resistor on OPAMP output

Resistor value between OPAMP outputs and I/O (PA3 or PB0) is greater than expected: 8 Ω typical, as shown in [Figure 3](#). As a consequence the OPAMP characteristics can be impacted depending on the current sunk on the output.

None.

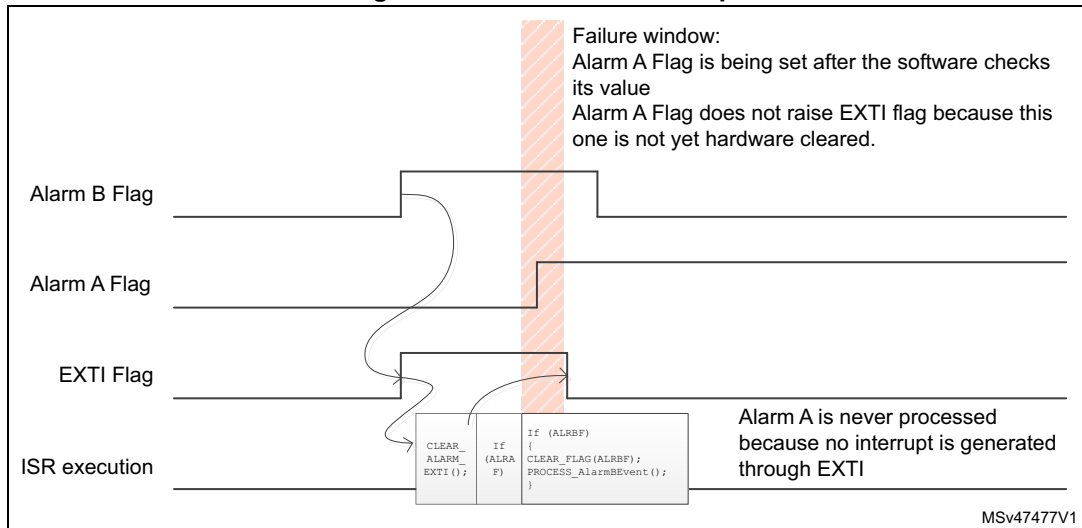
Figure 4. Masked RTC interrupt

The following code example and figure illustrate the failure mechanism: The Alarm A event is lost (fails to generate interrupt) as it occurs in the failure window, that is, after checking the Alarm A event flag but before the effective clear of the EXTI interrupt flag by hardware. The effective clear of the EXTI interrupt flag is delayed with respect to the software instruction to clear it.

In the interrupt service routine, apply three consecutive event flag checks - source one, source two, and source one again, as in the following code example:
