ST10F276E, ST10F275E, ST10F273E Errata sheet

16-bit MCUs with
512/768/832 KByte Flash and 36/36/68 KByte RAM memories

This errata sheet describes all the functional and electrical problems known in the Cxx silicon versions of the ST10F276E, ST10F275E and ST10F273E.

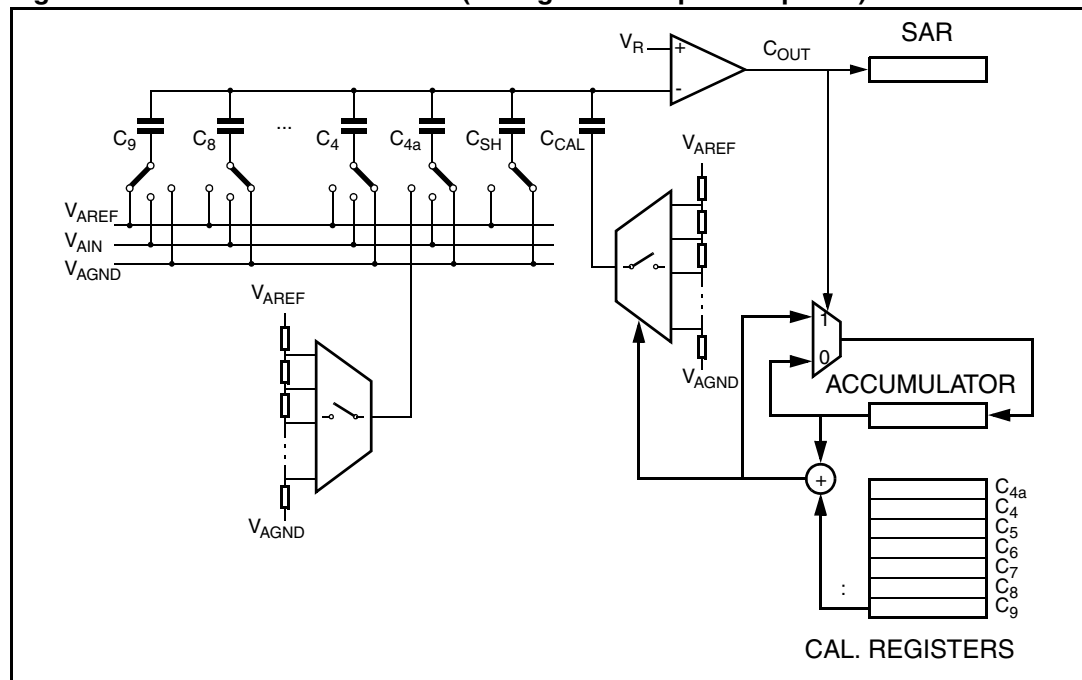
Figure 1. Calibration mechanism (during bit 9 comparison phase)

On specific analog input values an accuracy degradation of several LSBs may be seen on the digital output value of the implemented ADC. In particular this occurs if the input voltage matches the internal comparator thresholds, which is when a roll over from the least significant bits (that is, 0x1Fh -> 0x20h or viceversa) occurs.

The maximum deviation in accuracy is ± 250 mV over the entire conversion range.

The failure is linked to the implemented “self calibrating circuitry” which is summarized in the [Figure 1](#).

The maximum correction applied by the calibration is 250 mV.

When the analog input voltage is close to one of the thresholds of the comparator (by less than 1 mV), then the amplifier sees a differential voltage very close to zero. As a result, the output of the comparator is fluctuating between the values “0” or “1”. Because of the parallel use of the comparator output and of the fluctuating value, different values may be latched in the SAR (successive approximation register) and the calibration section. As a result a bad calibration mechanism is applied to the successive bit.

It is not possible to define a workaround generic for all applications.

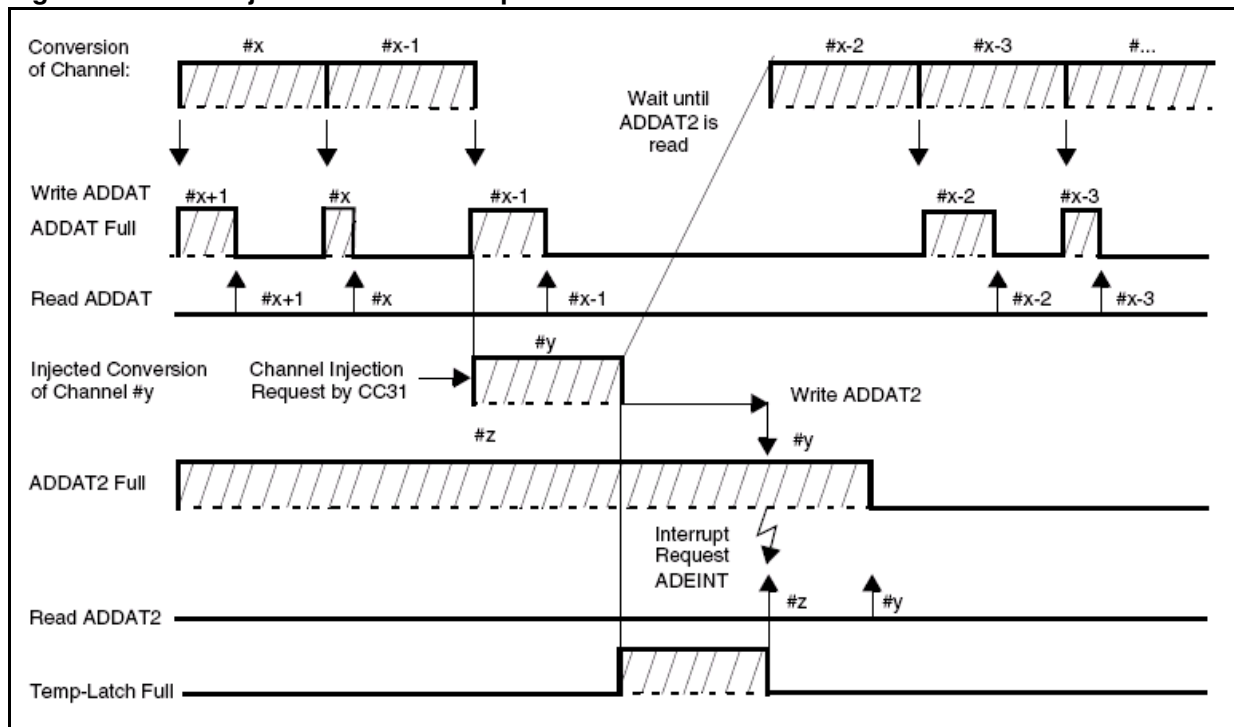
Figure 2. ADC injection theoretical operation

If the temporary data register used for ADDAT2 Read mode is full and a new injection request is issued then the new converted value is stored into a temporary data register until the previous one is read from ADDAT2.

For a correct functionality as soon as ADDAT2 register is read then the last converted value should be moved from temporary register to ADDAT2 and the ADEINT interrupt request should be issued. This would allow the CPU to read the last converted value (see [Figure 2](#)).

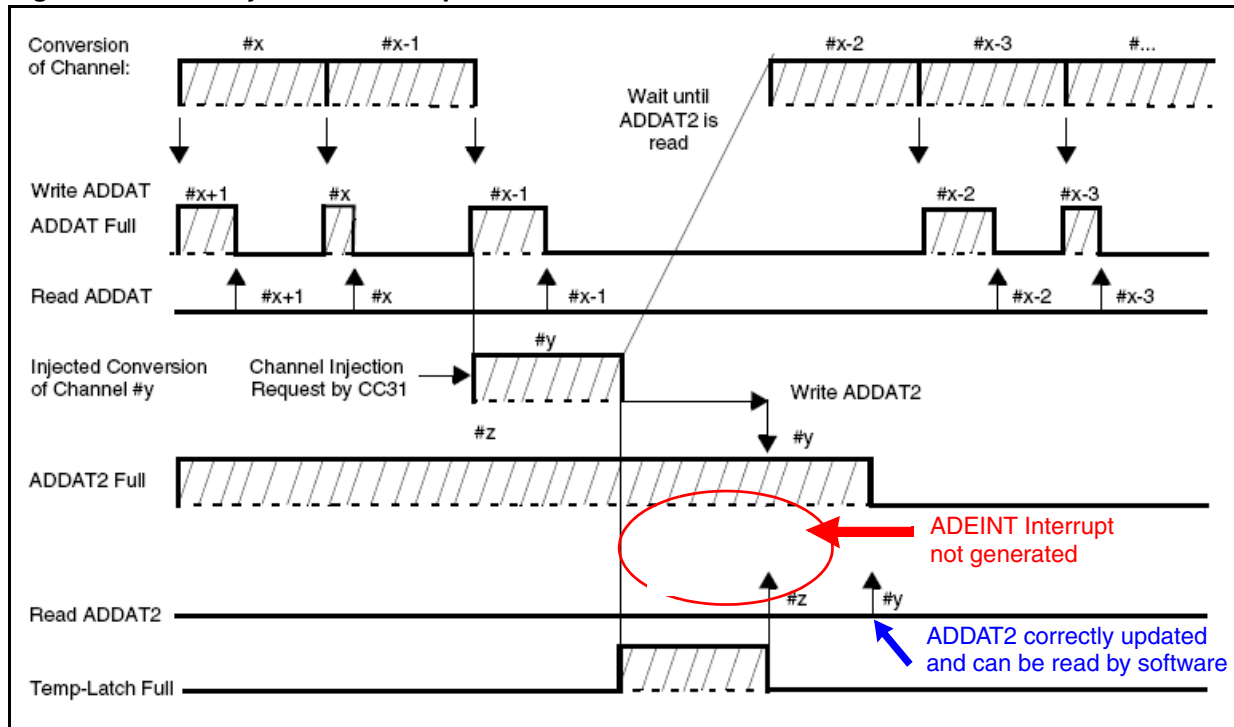
Figure 3. ADC injection actual operation

Whenever a new Injection request is issued before the ADDAT2 register has been read by the CPU (that is the result of the previous injection request was not read), the ADC is stalled and no further conversions are performed.

In the real situation as soon as ADDAT2 register is read then the last converted value is correctly moved from temporary register to ADDAT2 but **the ADEINT interrupt request is not received by the interrupt controller** (see [Figure 3](#)). As a consequence the CPU/PEC never knows that a new converted value is ready to be read in ADDAT2 register and therefore at the following injection request the ADC fills the temporary register again (without generating any ADEINT interrupt request) and then stalls the ADC for any further conversion. The ADC stays in the “wait-for-read ADDAT2 register” condition forever.

1. Read the ADDAT2 register twice at the end of every injected conversion (also prevents stall condition to occur)
2. Disable then re-enable the wait-for-read mode

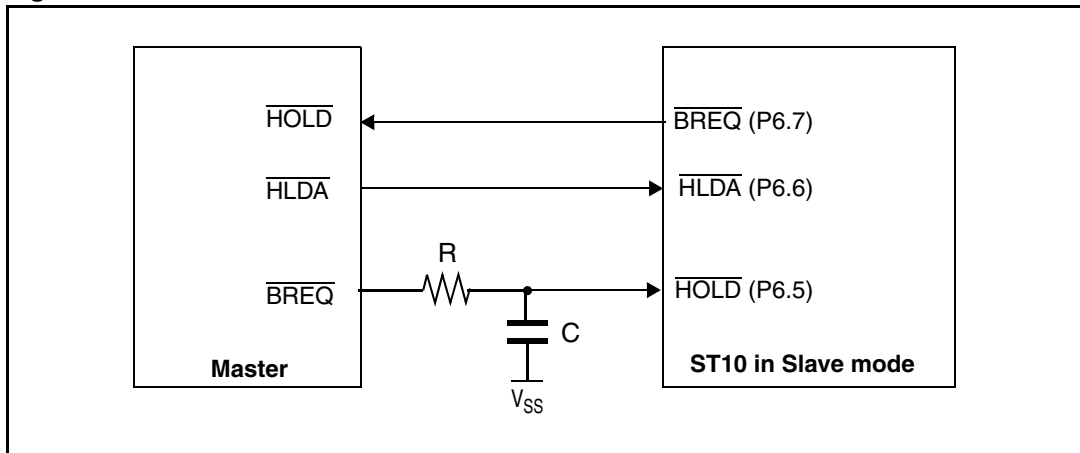
Figure 4. ST10 in slave mode

When using external bus arbitration via HOLD-function with the ST10F276 configured as a slave, sporadic bus errors may occurs.

After the slave has been granted the bus, the slave deactivates BREQ sporadically for a short time, even though the bus access of the slave has not been completed. The master then starts its own bus access, leading to a bus conflict between master and slave.

In order not to produce any spurious BREQ pulse during a slave external bus arbitration phase, it is necessary to guarantee that the distance between the HOLDA assertion (bus acknowledge from master device) and the following HOLD falling edge (bus request from master) is greater than three clock cycles.

This can be implemented by delaying the HOLD signal with a RC circuit as shown in [Figure 4](#).
