STM32L496xx/4A6xx device errata

Applicability

This document applies to the part numbers of STM32L496xx/4A6xx devices and the device variants as stated in this page.

It gives a summary and a description of the device errata, with respect to the device datasheet and reference manual RM351.

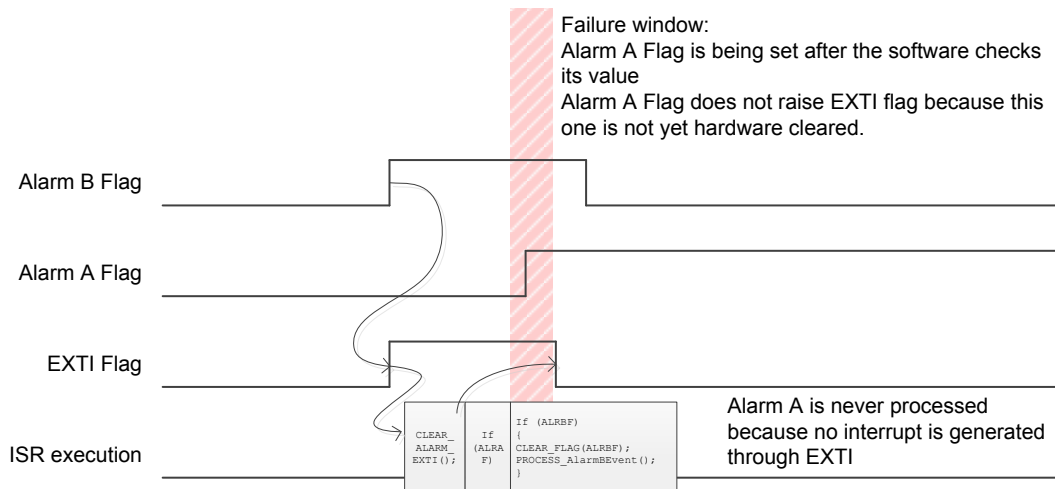
Figure 1. Masked RTC interrupt

The following code example and figure illustrate the failure mechanism: The Alarm A event is lost (fails to generate interrupt) as it occurs in the failure window, that is, after checking the Alarm A event flag but before the effective clear of the EXTI interrupt flag by hardware. The effective clear of the EXTI interrupt flag is delayed with respect to the software instruction to clear it.

In the interrupt service routine, apply three consecutive event flag checks - source one, source two, and source one again, as in the following code example:
