STM32F101x4/6, STM32F102x4/6, STM32F103x4/6 device errata

This document applies to the part numbers of STM32F101x4/6, STM32F102x4/6, STM32F103x4/6 devices and the device variants as stated in this page.

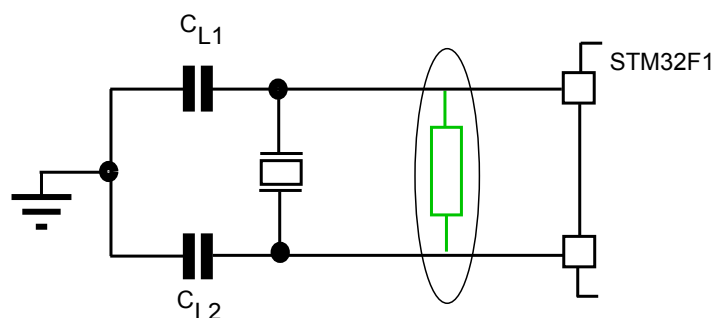
Figure 1. LSE startup using an additional resistor

The LSE (low-speed external) oscillator system has been designed to minimize the overall power consumption of the microcontroller. It is extremely important to take specific care in the design of the PCB to ensure this low power oscillator starts in harsh conditions. In some PCB designs without coating, an induced low leakage may prevent the LSE to startup, regardless of the 32.768 KHz crystal used. This phenomenon is amplified in humid environments that create frost on the OSC32_IN/OSC32_OUT tracks. This unwanted behavior may happen only at the first back-up domain power-on of the device.

It is recommended to mount an additional parallel feedback resistor (from 16 M Ω to 22 M Ω) on board to help the oscillation startup in all cases (see [Figure 1](#)). For more details on compatible crystals and hardware techniques on PCB, refer to application note *Oscillator design guide for STM8AF/AL/S, STM32 MCUs and MPUs* (AN2867).
