STM8S007xx and STM8S20xxx device limitations

Silicon identification

This errata sheet applies to revisions X, Y/6, V, W/7 and 1 of the STMicroelectronics STM8S007xx and STM8S20xxx products.

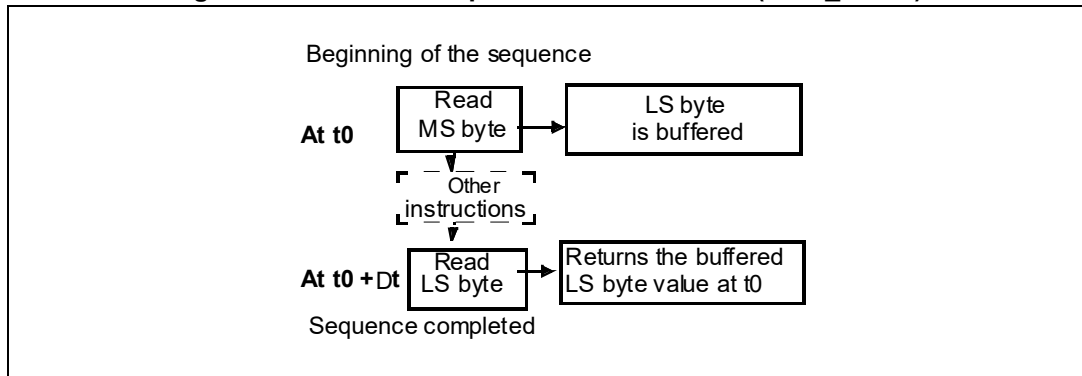
Figure 1. 16-bit read sequence for the counter (TIMx_CNTR)

An 8-bit buffer is implemented for reading the 16-bit counter registers. Software must read the MS byte first, after which the LS byte value is buffered automatically (see [Figure 1](#)). This buffered value remains unchanged until the 16-bit read sequence is completed.

When any multi-cycle instruction precedes the read of the LSB, the content of the buffer is lost and the second read returns the immediate content of the counter directly.

Do not use multi-cycle instructions before reading the LSB.
