### STM32F413xG/xH and STM32F423xH device errata

This document applies to the part numbers of STM32F413xG/xH and STM32F423xH devices and the device variants as stated in this page.

It gives a summary and a description of the device errata, with respect to the device datasheet and reference manual RM0430.

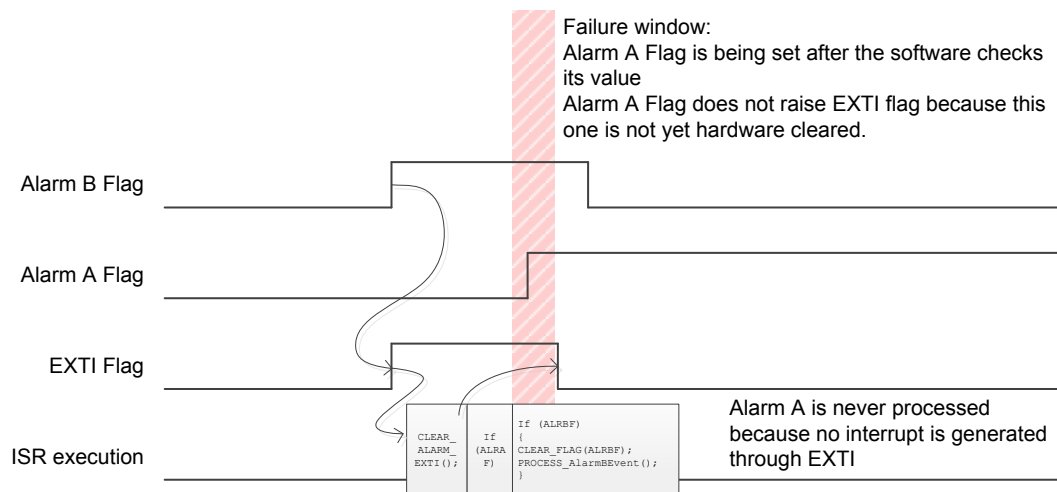
Figure 1. Masked RTC interrupt

The following code example and figure illustrate the failure mechanism: The Alarm A event is lost (fails to generate interrupt) as it occurs in the failure window, that is, after checking the Alarm A event flag but before the effective clear of the EXTI interrupt flag by hardware. The effective clear of the EXTI interrupt flag is delayed with respect to the software instruction to clear it.
