STM32L4Rxxx and STM32L4Sxxx device errata

This document applies to the part numbers of STM32L4Rxxx and STM32L4Sxxx devices and the device variants as stated in this page.

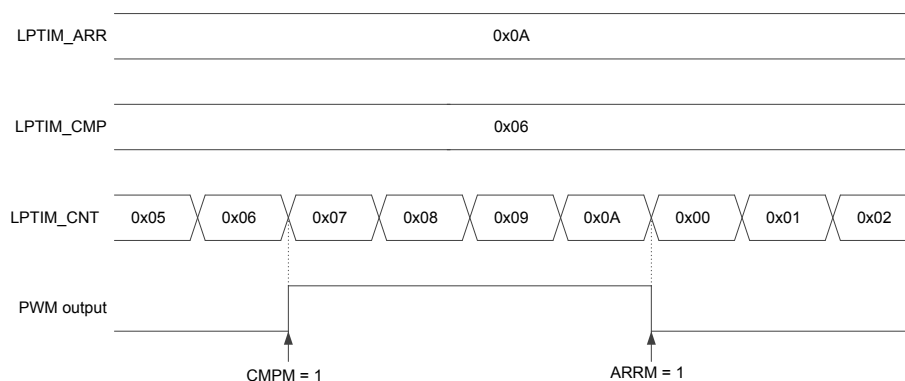
Consequently, it is not possible to generate PWM with a duty cycle of 0% or 100%.

The following waveform gives the example of PWM output mode and the effect of the delay:

Set the compare value to the desired value minus 1. For instance in order to generate a compare match when LPTIM_CNT = 0x08, set the compare value to 0x07.

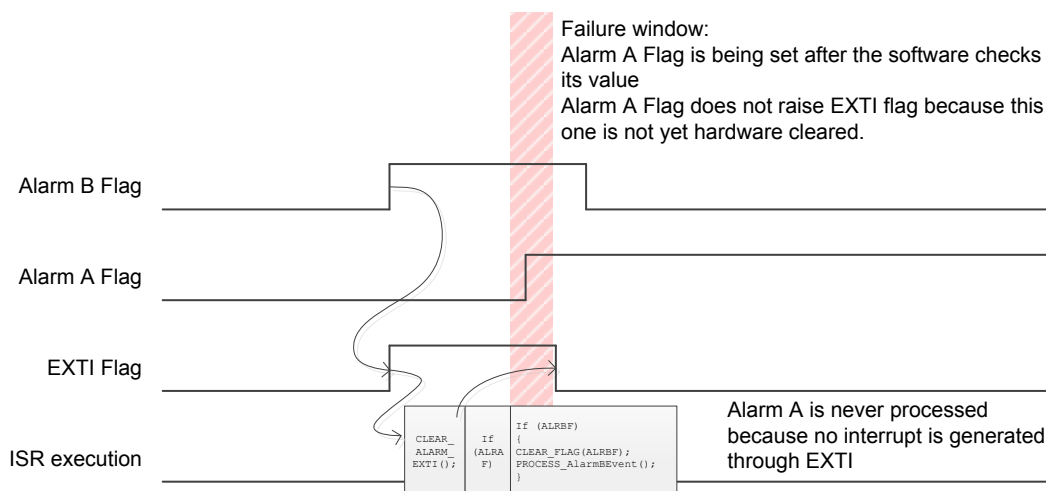
Figure 1. Masked RTC interrupt

The following code example and figure illustrate the failure mechanism: The Alarm A event is lost (fails to generate interrupt) as it occurs in the failure window, that is, after checking the Alarm A event flag but before the effective clear of the EXTI interrupt flag by hardware. The effective clear of the EXTI interrupt flag is delayed with respect to the software instruction to clear it.

In the interrupt service routine, apply three consecutive event flag checks - source one, source two, and source one again, as in the following code example:
