STM32WB55xx/STM32WB35Cx device errata

This document applies to the part numbers of STM32WB55xx/STM32WB35Cx devices and the device variants as stated in this page.

It gives a summary and a description of the device errata, with respect to the device datasheet and reference manual RM0434.

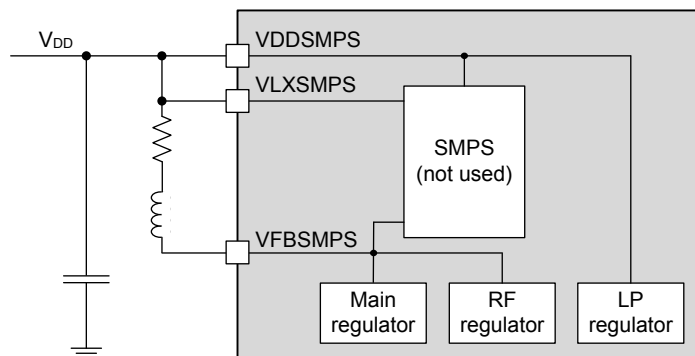
Figure 1. Workaround

The Hard Fault can be observed in case SYSCLK=HSE. Otherwise the risk is radio malfunction since clocked from HSE directly too.

The recommended inductor characteristics are the inductance 1.8 nH +/- 0.1 nH, self-resonance frequency of 6 Ghz +/-15 %, and rated current of 1000 mA. The resistor of 2.2 Ω recommended resistance must be dimensioned to dissipate 1 watt during 5 ns. Refer to [Minimal BOM for STM32WB Series microcontrollers \(AN5290\)](#) for more details.

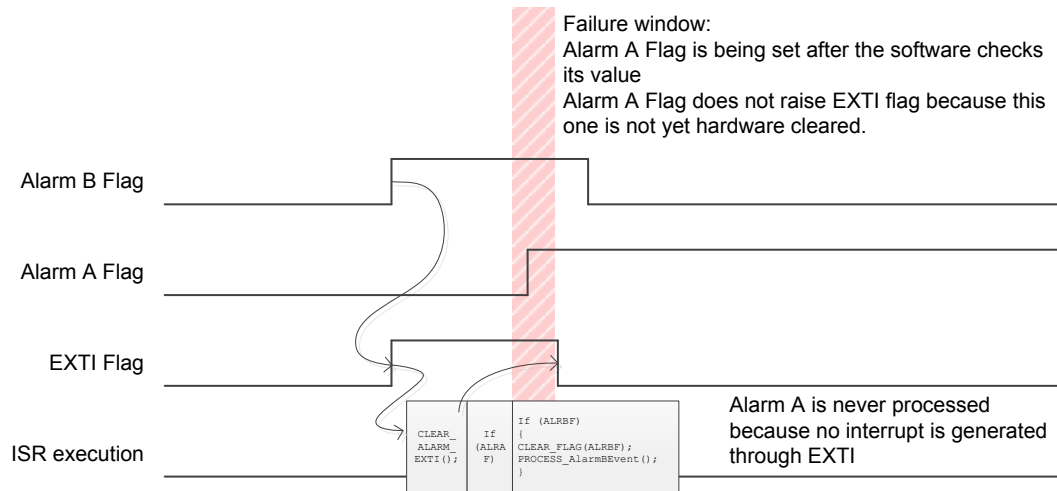
Figure 2. Masked RTC interrupt

The following code example and figure illustrate the failure mechanism: The Alarm A event is lost (fails to generate interrupt) as it occurs in the failure window, that is, after checking the Alarm A event flag but before the effective clear of the EXTI interrupt flag by hardware. The effective clear of the EXTI interrupt flag is delayed with respect to the software instruction to clear it.

In the interrupt service routine, apply three consecutive event flag checks - source one, source two, and source one again, as in the following code example:
