STM32G431xx/441xx device errata

Applicability

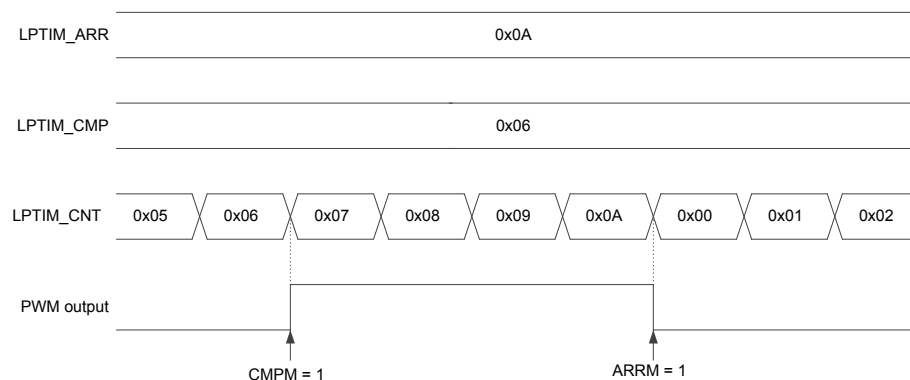
Consequently, it is not possible to generate PWM with a duty cycle of 0% or 100%.

The following waveform gives the example of PWM output mode and the effect of the delay:

Workaround

Set the compare value to the desired value minus 1. For instance in order to generate a compare match when LPTM_CNT = 0x08, set the compare value to 0x07.
