## The BlueNRG-2 device limitations

### Silicon identification

This errata sheet applies to the following STMicroelectronics BlueNRG-2 devices:

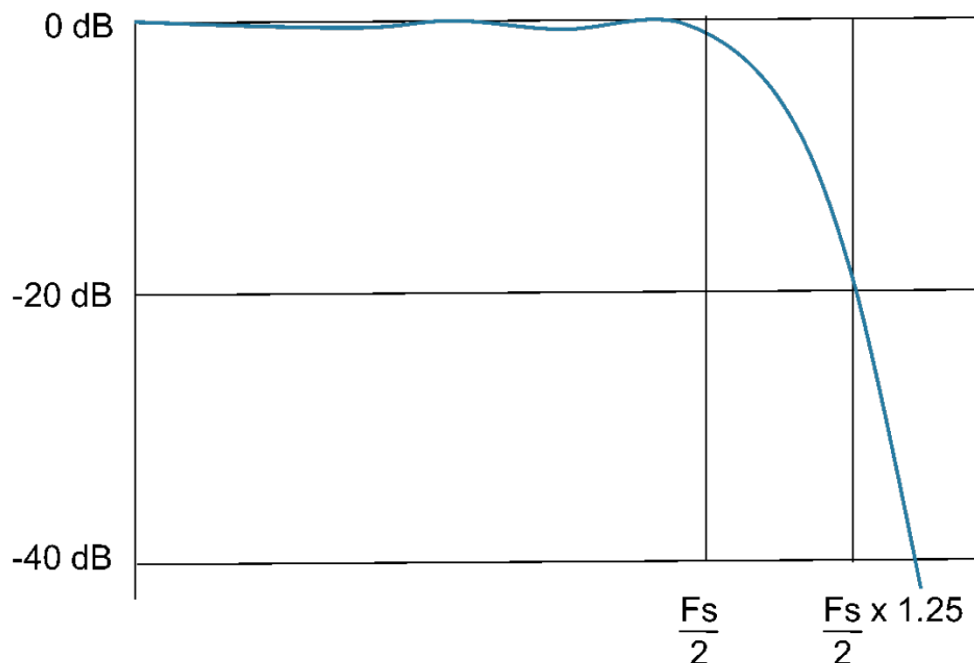
**Figure 1. Interpolation filter frequency response**

**Description:** the bandwidth of the anti-aliasing filter is slightly broader with respect to the signal bandwidth, potentially thus generating unwanted aliased signal after the decimation filter.

**Impact:** When a pure sine wave, generated in the  $[Fs/2; 1.25*Fs/2]$  range, is being sampled, user can notice an attenuated aliased sine wave in the  $[0.75*Fs/2; Fs/2]$  range.

In case of waveform acquisition, especially when audio speech and music is caught, no further degradation has been identified.

**Workaround:** by choosing an appropriate oversampling factor (OSR), so that maximum frequency of the sampled signal is lower than  $F_s/2$ , aliasing may be avoided.
