STM32L010xx device errata

This document applies to the part numbers of STM32L010xx devices and the device variants as stated in this page.

It gives a summary and a description of the device errata, with respect to the device datasheet and reference manual RM0451.

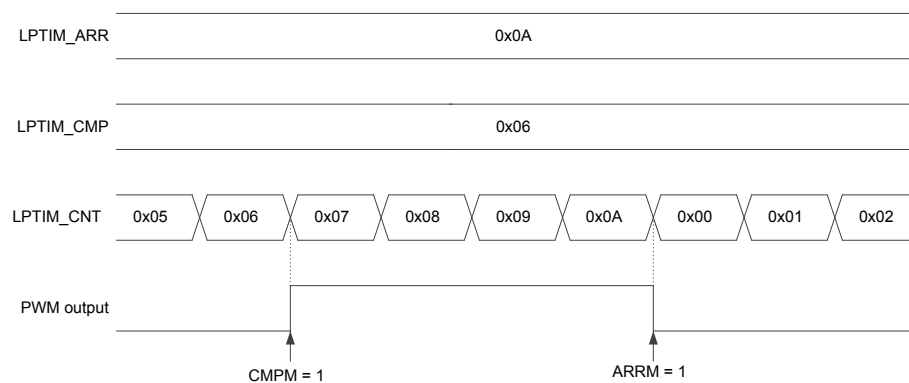
Consequently, it is not possible to generate PWM with a duty cycle of 0% or 100%.

The following waveform gives the example of PWM output mode and the effect of the delay:

Set the compare value to the desired value minus 1. For instance in order to generate a compare match when LPTIM_CNT = 0x08, set the compare value to 0x07.
