STM32H72xx/73xx device errata

Applicability

This document applies to the part numbers of STM32H72xx/73xx devices and the device variants as stated in this page. It gives a summary and a description of the device errata, with respect to the device datasheet and reference manual RM0468. Deviation of the real device behavior from the intended device behavior is considered to be a device limitation. Deviation of the description in the reference manual or the datasheet from the intended device behavior is considered to be a documentation erratum. The term “*errata*” applies both to limitations and documentation errata.

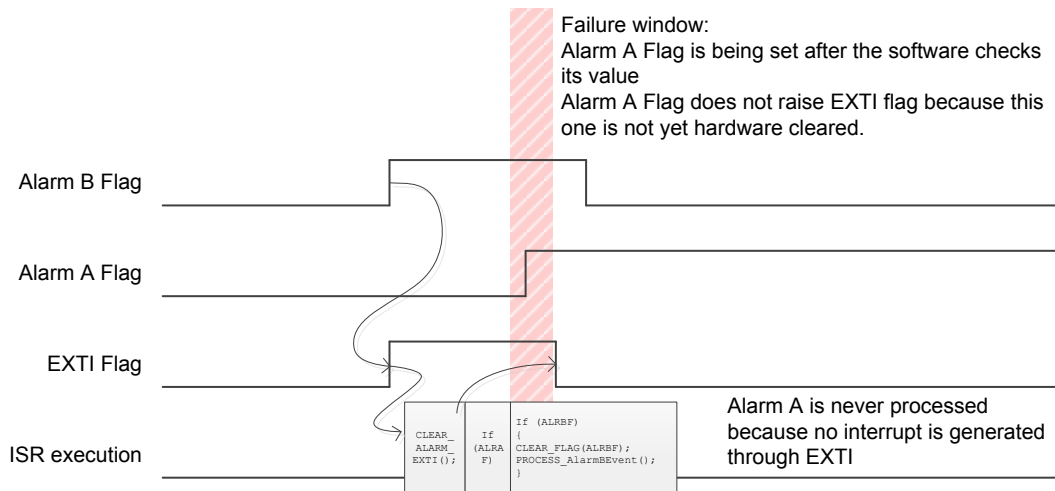
Figure 1. Masked RTC interrupt

The following code example and figure illustrate the failure mechanism: The Alarm A event is lost (fails to generate interrupt) as it occurs in the failure window, that is, after checking the Alarm A event flag but before the effective clear of the EXTI interrupt flag by hardware. The effective clear of the EXTI interrupt flag is delayed with respect to the software instruction to clear it.

In the interrupt service routine, apply three consecutive event flag checks - source one, source two, and source one again, as in the following code example:
