## STM32G491xx/4A1xx device errata

This document applies to the part numbers of STM32G491xx/4A1xx devices and the device variants as stated in this page. It gives a summary and a description of the device errata, with respect to the device datasheet and reference manual RM0440. Deviation of the real device behavior from the intended device behavior is considered to be a device limitation. Deviation of the description in the reference manual or the datasheet from the intended device behavior is considered to be a documentation erratum. The term “errata” applies both to limitations and documentation errata.

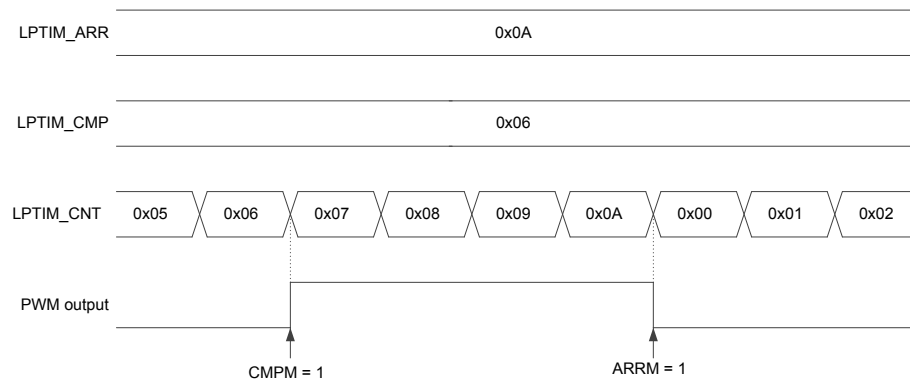
Consequently, it is not possible to generate PWM with a duty cycle of 0% or 100%.

The following waveform gives the example of PWM output mode and the effect of the delay:

Set the compare value to the desired value minus 1. For instance in order to generate a compare match when LPTM\_CNT = 0x08, set the compare value to 0x07.
