STM32G491xx/4A1xx device errata

Applicability

This document applies to the part numbers of STM32G491xx/4A1xx devices and the device variants as stated in this page. It gives a summary and a description of the device errata, with respect to the device datasheet and reference manual RM0440. Deviation of the real device behavior from the intended device behavior is considered to be a device limitation. Deviation of the description in the reference manual or the datasheet from the intended device behavior is considered to be a documentation erratum. The term “*errata*” applies both to limitations and documentation errata.

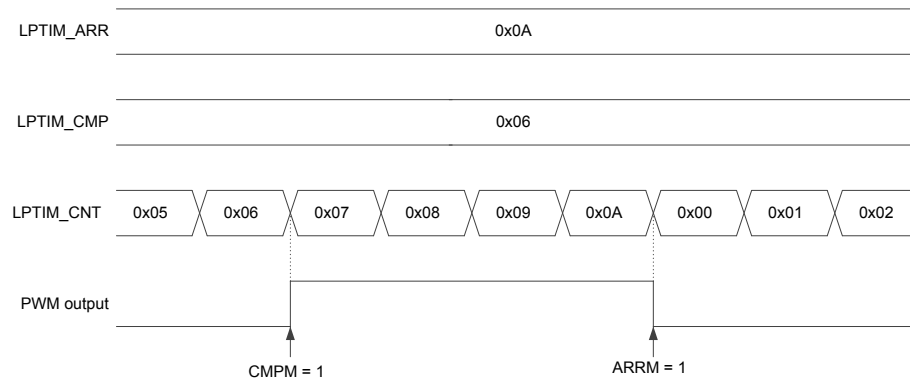
Consequently, it is not possible to generate PWM with a duty cycle of 0% or 100%.

The following waveform gives the example of PWM output mode and the effect of the delay:

Workaround

Set the compare value to the desired value minus 1. For instance in order to generate a compare match when LPTM_CNT = 0x08, set the compare value to 0x07.
