**Device limitations for STM8AF6366 automotive MCUs featuring up to 32 Kbytes of Flash program memory**

This document applies to the STM8AF6366 devices.

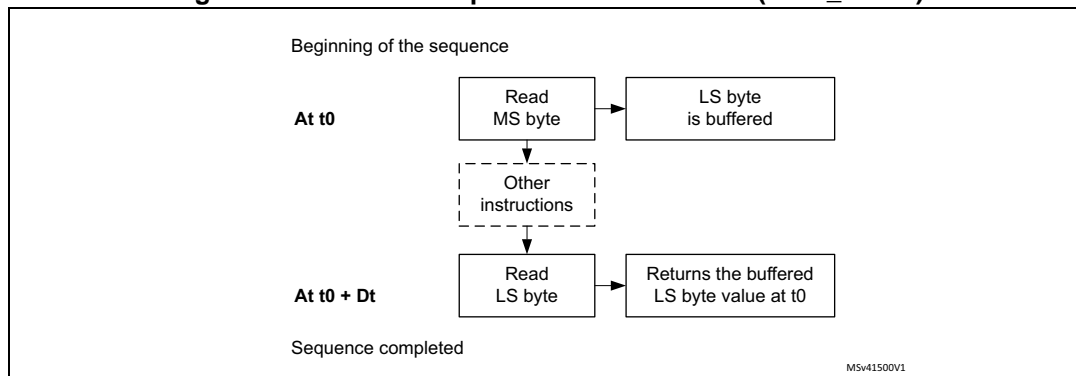
**Figure 1. 16-bit read sequence for the counter (TIMx\_CNTR)**

An 8-bit buffer is implemented for reading the 16-bit counter registers. Software must read the MS byte first, after which the LS byte value is buffered automatically (see the figure below). This buffered value remains unchanged until the 16-bit read sequence is completed.

When any multi-cycle instruction precedes the read of the LSB, the content of the buffer is lost and the second read returns the immediate content of the counter directly.

Do not use multi-cycle instructions before reading the LSB.
