**Device limitations for STM8AF6388 automotive MCUs featuring up to 128 Kbytes of Flash program memory**

This document applies to the STM8AF6388 devices.

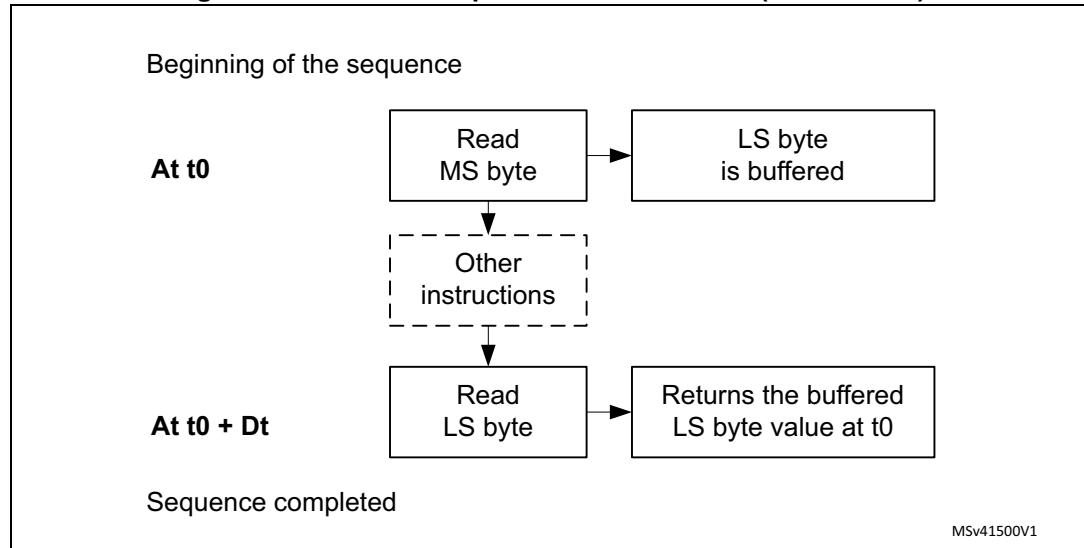
Figure 1. 16-bit read sequence for the counter (TIMx\_CNTR)

When any multi-cycle instruction precedes the read of the LSB, the content of the buffer is lost and the second read returns the immediate content of the counter directly.

Do not use multi-cycle instructions before reading the LSB.
