## STM32MP131x/3x/5x device errata

This document applies to the part numbers of STM32MP131x/3x/5x devices and the device variants as stated in this page. It gives a summary and a description of the device errata, with respect to the device datasheet and reference manual RM0475. Deviation of the real device behavior from the intended device behavior is considered to be a device limitation. Deviation of the description in the reference manual or the datasheet from the intended device behavior is considered to be a documentation erratum. The term “*errata*” applies both to limitations and documentation errata.

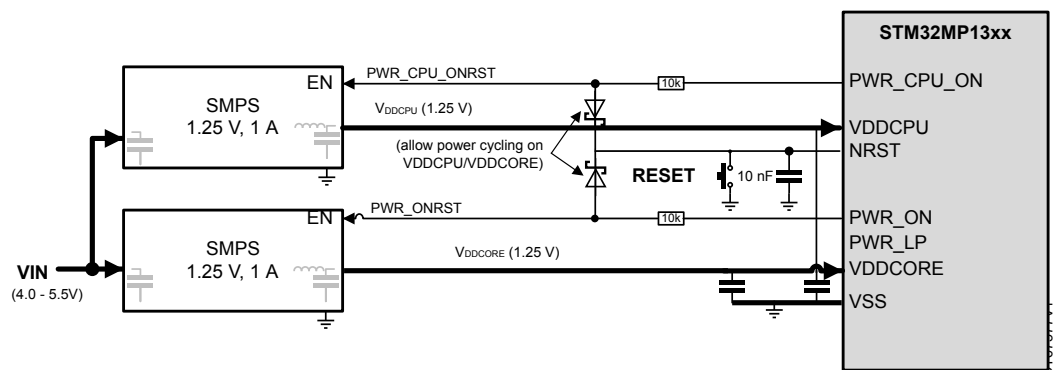
1. **By hardware**, ensure that the  $V_{DDCORE}$  and  $V_{DDCPU}$  logic is reset on NRST activation:
  - **With STPMIC1**  
By default, a power cycle on  $V_{DDCORE}$  and  $V_{DDCPU}$  (and  $V_{DD}$ ) occurs upon activating NRST.
  - **Without STPMIC1**  
Connect the POWER\_CPU\_ON and PWR\_ON signals to the external SMPS enable inputs as illustrated next.

Activating NRST then causes the  $V_{DDCPU}$  and  $V_{DDCORE}$  supply voltages to cycle.

The drawback is that, the debug logic also being reset, it is not possible to debug the boot chain (TF-A and U-Boot) as any breakpoints set are lost during the power cycle.

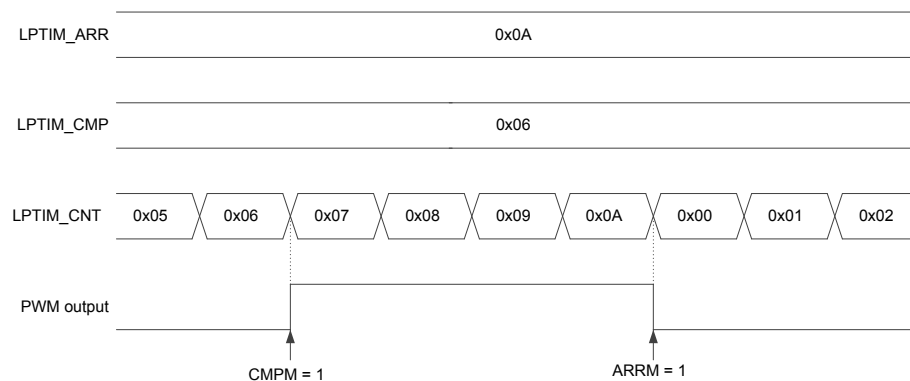
Consequently, it is not possible to generate PWM with a duty cycle of 0% or 100%.

The following waveform gives the example of PWM output mode and the effect of the delay:

Set the compare value to the desired value minus 1. For instance in order to generate a compare match when LPTM\_CNT = 0x08, set the compare value to 0x07.
