STM32L100 Value Line device errata

This document applies to the part numbers of STM32L100 Value Line devices and the device variants as stated in this page.

It gives a summary and a description of the device errata, with respect to the device datasheet and reference manual RM0038.

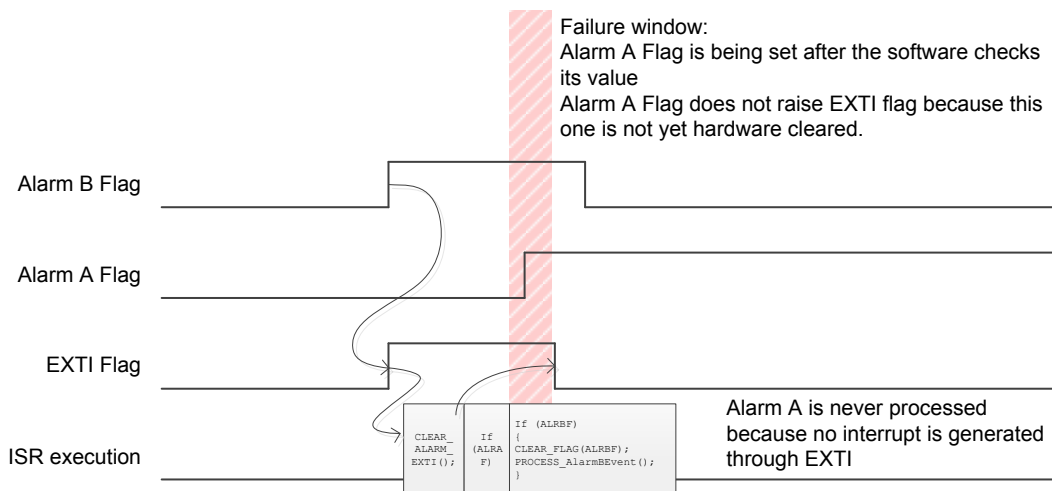
Figure 1. Masked RTC interrupt

The following code example and figure illustrate the failure mechanism: The Alarm A event is lost (fails to generate interrupt) as it occurs in the failure window, that is, after checking the Alarm A event flag but before the effective clear of the EXTI interrupt flag by hardware. The effective clear of the EXTI interrupt flag is delayed with respect to the software instruction to clear it.

Workaround

In the interrupt service routine, apply three consecutive event flag checks - source one, source two, and source one again, as in the following code example:
