ST25DV04K, ST25DV16K and ST25DV64K device limitations

Silicon identification

The ST25DV-I2C series is a dynamic NFC/RFID tag ICs with 4, 16 or 64-Kbit EEPROM and Fast transfer mode capability.

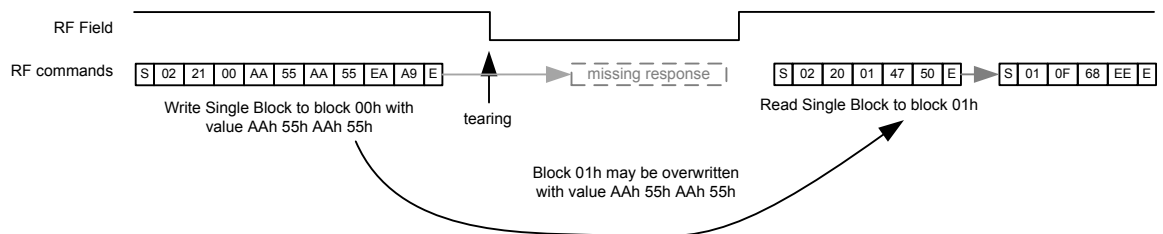
Figure 1. Wrong memory address potentially overwritten after tearing during an RF write in EEPROM when V_{CC} is present

If the following conditions are met:

- V_{CC} is powered during the complete operation
- RF field is lost during the EEPROM programming phase of any RF write command to EEPROM
- next RF command is any command that reads data from the EEPROM

Then, depending on the tearing timing in the programming phase, the memory content can potentially be overwritten at block address pointed by the RF read command that follows the tearing.

Any memory address can be overwritten, including read-only addresses.

For devices with product codes 25h and 27h the following workaround can be used.

The LPD pin must be permanently kept at high level when V_{CC} is present, and must be pulled to low level only during transmission of I²C commands to the ST25DV-I2C.

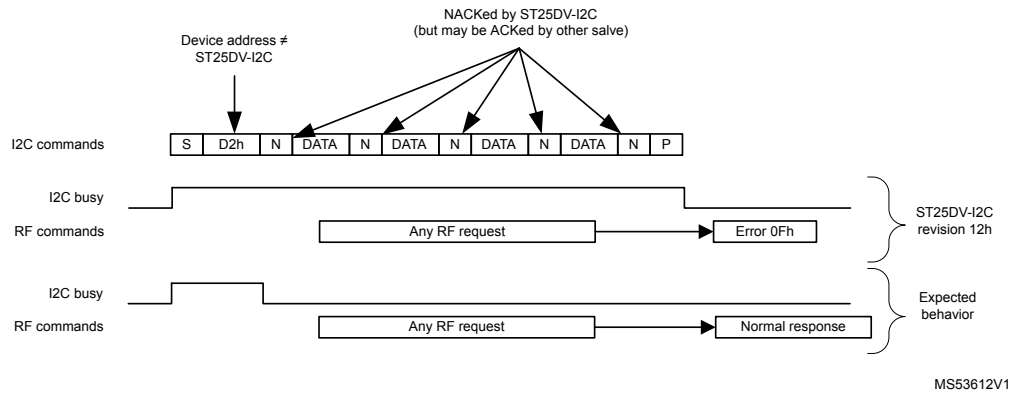
Figure 3. I²C busy state not released after an I²C error

When an error occurs in any I²C frame (implying the return of a no ACK bit by the ST25DV-I2C), the arbitration does not release the exclusive access and stays in I²C busy state until the stop condition (or the I²C timeout condition) is reached.

As a consequence, any RF command received after a no ACK condition and before the I²C stop condition (or I²C timeout), is not answered or answered with error 0Fh.

In case of intense traffic on the I²C bus (i.e. multiple slave devices with several frequent accesses), this limitation can create latency or difficult communication from RF.

This limitation has been fixed in devices with product codes 24h and 26h in revision 13h.

For devices with product codes 25h and 27h, the following workaround can be used.

The LPD pin must be permanently kept at high level when VCC is present, and must be pulled to low level only during transmission of I²C commands to the ST25DV-I2C.
