## ST25DV04KC, ST25DV16KC and ST25DV64KC device limitations

## Silicon identification

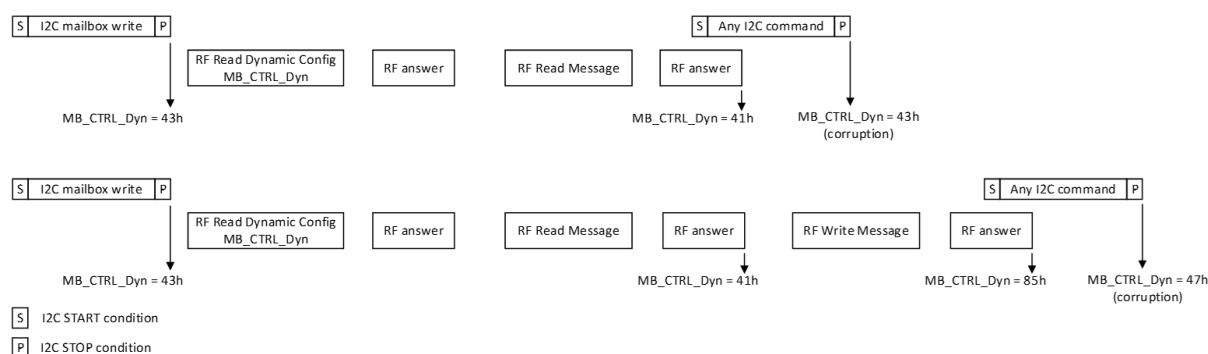
**Figure 1. Corruption**

After the I<sup>2</sup>C controller has written a message into the mailbox, if the next I<sup>2</sup>C command starts (START condition) during the RF answer of an RF access (read or write) to the mailbox, and stops (STOP condition) after this RF answer, then the MB\_CTRL\_Dyn and MB\_LEN\_Dyn registers get corrupted.
