STM32H5Exxx/5Fxxx device errata

Applicability

Table 1. Device summary

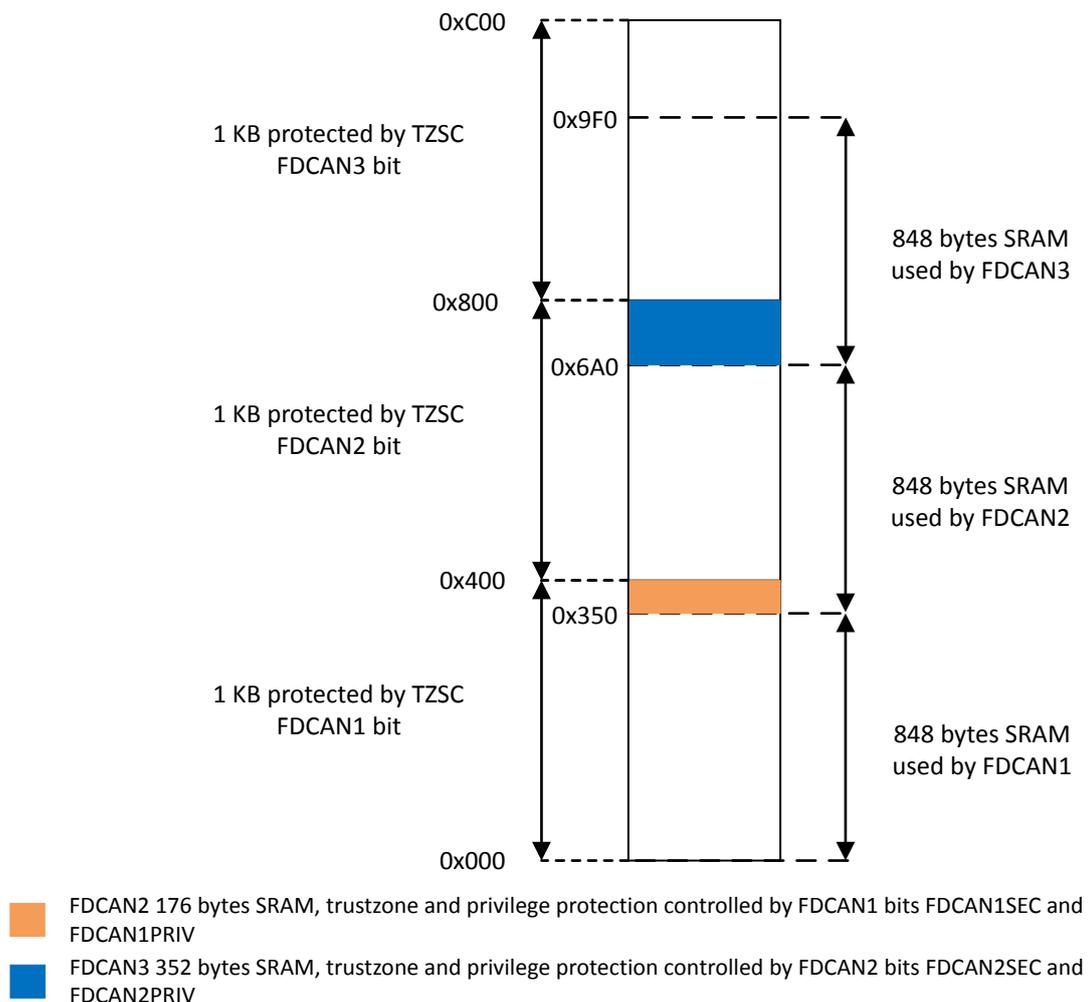
Figure 1. FDCAN instances

- Conversely, if FDCAN2 is nonsecure (or nonprivileged) and FDCAN3 is secure (or privileged), the lower part of FDCAN3 memory might still be accessible, compromising the security of FDCAN3.

Configure FDCAN1, FDCAN2, and FDCAN3 to have the same security and/or privilege level. This ensures that the TrustZone® and/or privilege protection is uniformly applied across all FDCAN instances, preventing any unintended access or restriction.
