Applicability

This document applies to the part numbers of STM32L471xx devices listed in [Table 1](#) and their variants shown in [Table 2](#).

Table 1. Device summary

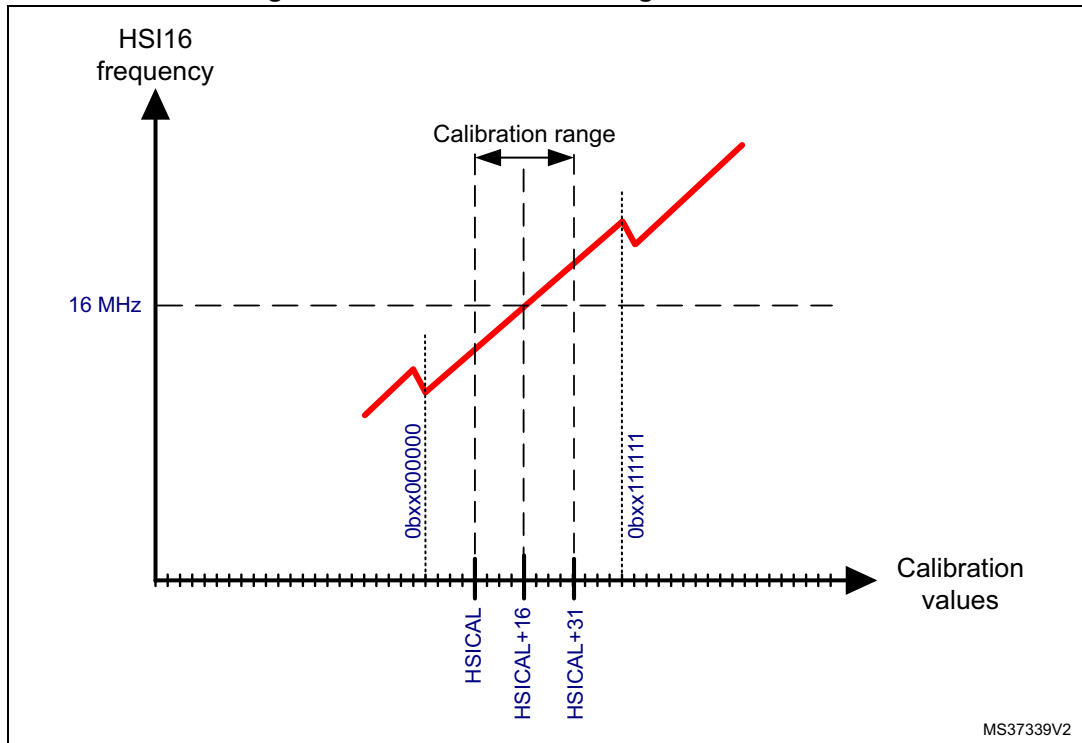
Figure 1. HSI oscillator trimming characteristics

Consequently, the user trim correction must not jump over the codes multiple of 64, which can limit the user correction either in positive or in negative direction.

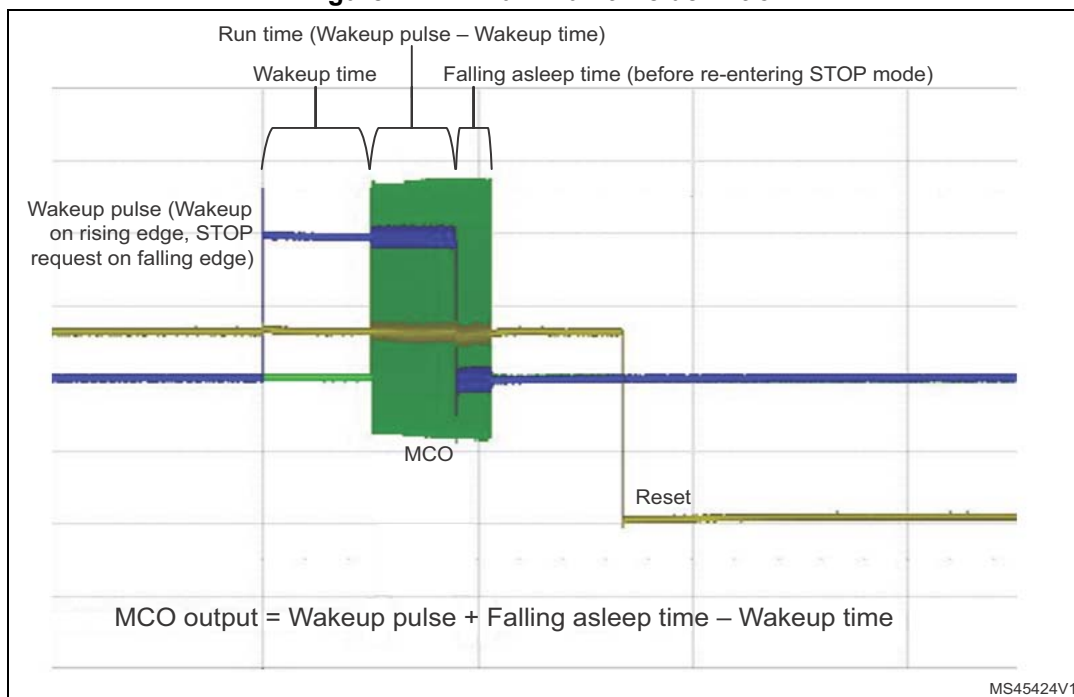
Figure 2. Minimum Run time definition

The minimum Run time defined in [Table 4](#) corresponds to the firmware execution time on the core. Note also that, as shown in [Figure 2](#), the length of the MCO output (green trace) is longer than the firmware execution time.

Ensure that the Run time between two Stop sequences is long enough to avoid the generation of a Brown Out Reset.

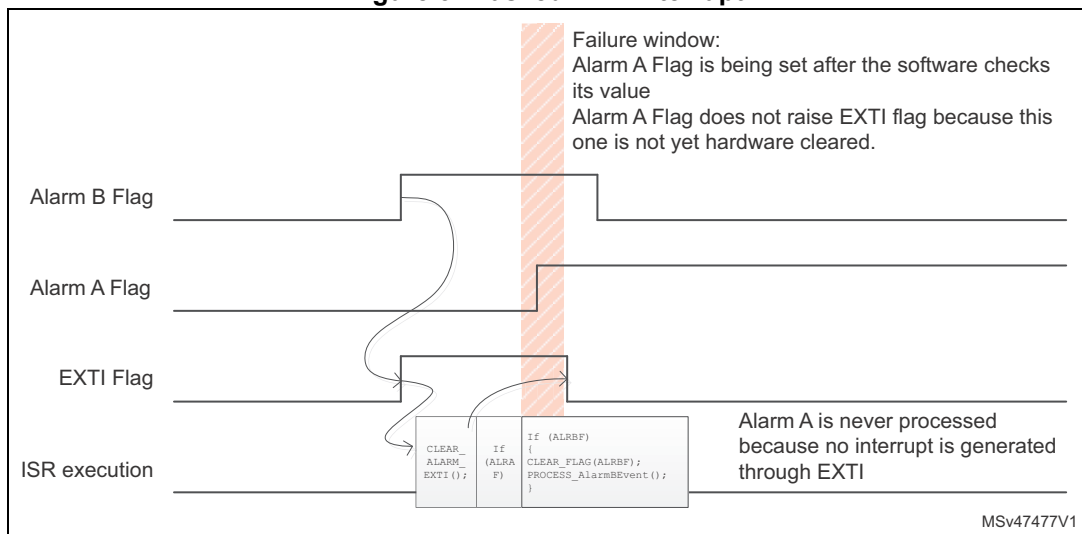
Figure 3. Masked RTC interrupt

The following code example and figure illustrate the failure mechanism: The Alarm A event is lost (fails to generate interrupt) as it occurs in the failure window, that is, after checking the Alarm A event flag but before the effective clear of the EXTI interrupt flag by hardware. The effective clear of the EXTI interrupt flag is delayed with respect to the software instruction to clear it.

In the interrupt service routine, apply three consecutive event flag checks - source one, source two, and source one again, as in the following code example:
