# Notes on EDC after ECC functionality

This application note describes what the possible causes of the FCCU fault channel EDC after ECC for Flash array are, and how the application can identify them.

This document applies to all microcontrollers belonging to the SPC58 family.

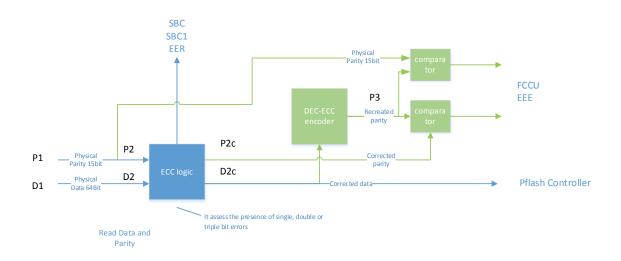
Figure 1. High-level schema of the ECC logic of the Flash (Dx is the data and Px is the parity)

As a consequence, the DEC-ECC encoder recreates the parity starting from D2c, and it gets P3 (the legal parity bits corresponding to D2c). Since P3 is different from P2, the comparator triggers an EEE event.

There are few cases - however - in which ECC logic does not detect the presence of a single, double, or triple-bit error, even though the couple P2/D2 is not legal. Consequently:

- P2 = P2c
- D2 = D2c

In this case, the DEC-ECC encoder recreates the parity P3 that is different than P2c  $^{(1.)}$ . As a result, the comparators assert the EEE event, even if there is not the assertion of SBC, SBC1, or EER flag.
