STM32L4P5xx/Q5xx device errata

Applicability

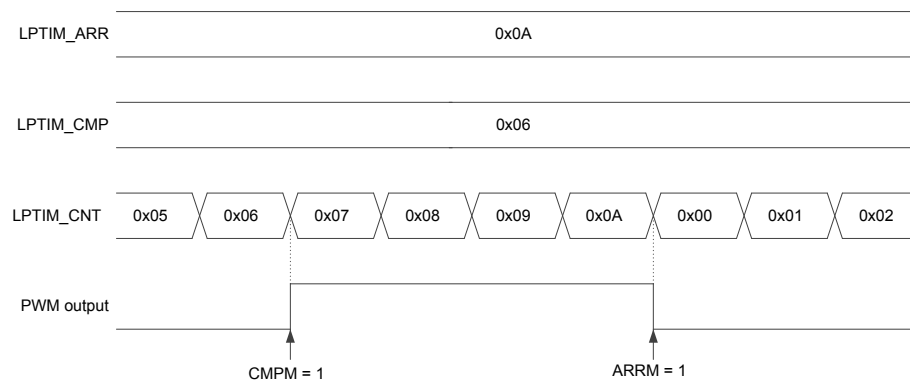
Consequently, it is not possible to generate PWM with a duty cycle of 0% or 100%.

The following waveform gives the example of PWM output mode and the effect of the delay:

Set the compare value to the desired value minus 1. For instance in order to generate a compare match when LPTM_CNT = 0x08, set the compare value to 0x07.
