Mode transition blocking by internal IPs clock busy signal

This document presents a possible mode transition stuck in mode entry module (MC_ME) for SPC58xx devices.

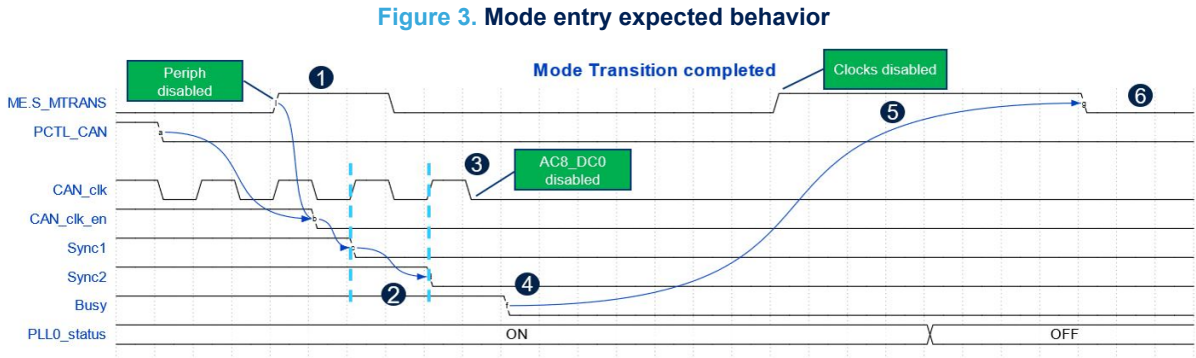
The following figure shows the working scenario on which a transition for disabling the peripheral, the next peripheral clock disable and the final mode transition for disabling all the clocks in the current user mode are successfully completed.

1. First mode transition to disable CAN_PCTL.
2. CAN clock propagation and synchronization.
3. CAN clock disabled via auxiliary clock divider.
4. Busy signal released.
5. Second mode transition for disabling clock sources (PLLx, XOSC).
6. Mode transition finished.

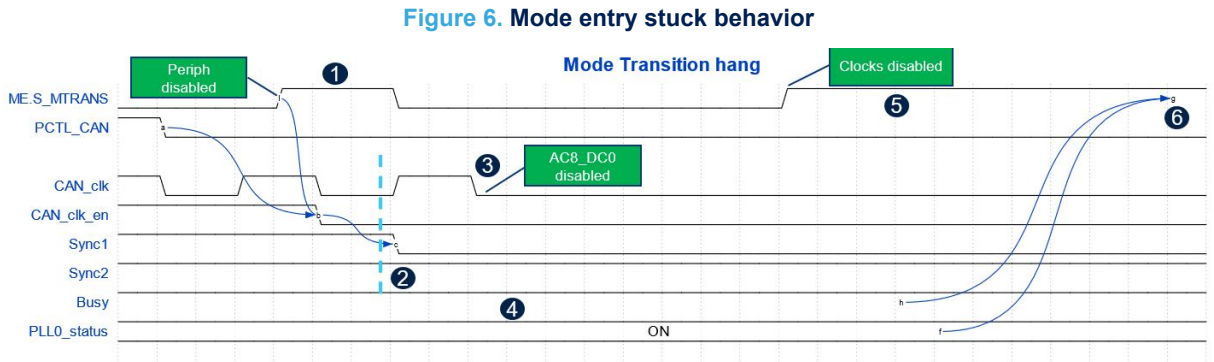
The following figure shows the scenario on which the final transition for disabling the clocks hangs.

1. First mode transition to disable CAN_PCTL.
2. CAN clock propagation and synchronization.
3. Slow CAN clock disable via auxiliary clock divider—during synchronization process.
4. Busy signal not released.
5. Second mode transition for disabling clock sources (PLLx, XOSC).
6. Mode transition pending—waiting for the busy signal release. It is not possible to disable clock source (PLL_0) to a periphery, which is using the clock source—signaled by the busy signal here. Similarly: XOSC cannot be disabled when used for PLL_0 as a source clock.

The wrong behavior is due to the CAN_clk, which is disabled via MC_CGM.AC8_DC0 (3) during the synchronization process. At this point, the busy signal (4) does not go low and the second transition (5) loops indefinitely, because (6) the PLL0 clock is expected to be switched off while busy signal is active.

Disabling the AC8_DC0 auxiliary clock divider at the beginning of the application completely avoid the phenomenon. No clocks remain active and the busy signal works properly.

Using a proper value in auxiliary clock dividers is the first mandatory step for avoiding the phenomenon. For each SPC58xx device there is a proper RM paragraph in the clocking chapter reporting the maximum auxiliary level clock frequencies. Please refer to the relative chapter for every detailed information (see Reference documents).
