STM32F412xE and STM32F412xG

Errata sheet

STM32F412xE and STM32F412xG device errata

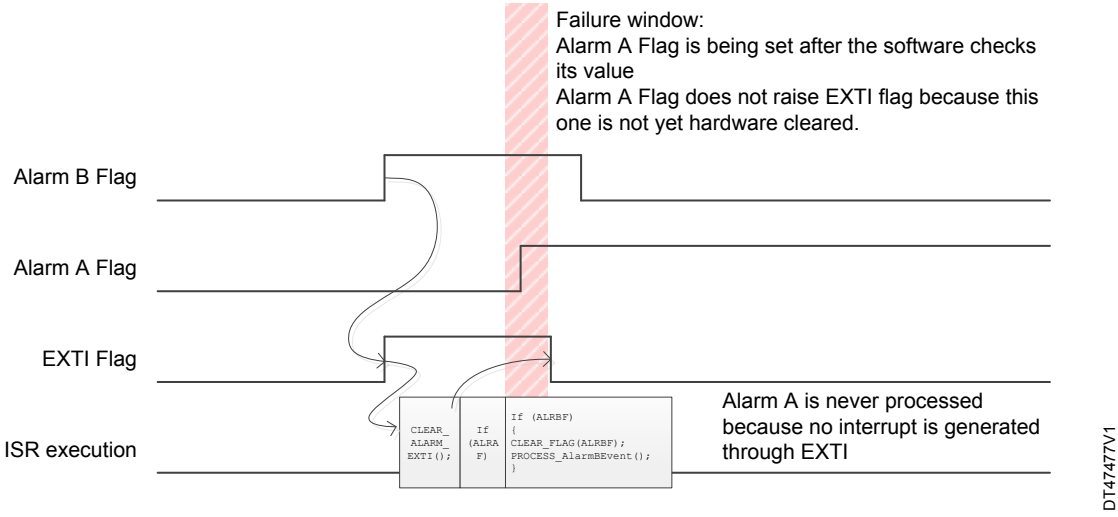
Figure 1. Masked RTC interrupt

The following code example and figure illustrate the failure mechanism: The Alarm A event is lost (fails to generate interrupt) as it occurs in the failure window, that is, after checking the Alarm A event flag but before the effective clear of the EXTI interrupt flag by hardware. The effective clear of the EXTI interrupt flag is delayed with respect to the software instruction to clear it.
