## Rev B and D limitations and corrections

### Silicon identification

This errata document covers the first group with rev B and rev D.

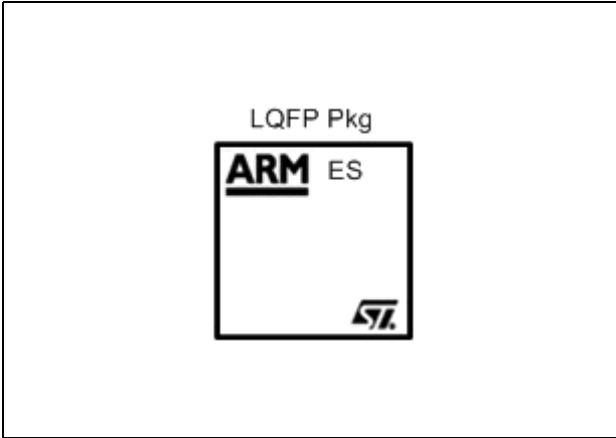
Figure 1. Device marking for Revision B Engineering Samples, LQFP128 packages

Salestype Group, External marking	Internal Silicon Revision	External Marking	Note
STR91xFxxxxx	B	ES	see <a href="#">Figure 1</a> . Initial Engineering Samples. LQFP128 pkgs.
	D	ES_D	see <a href="#">Figure 2</a> . Rev D Engineering Samples before week 18 of 2006. LQFP128 packages.
		Date code 618 or later	see <a href="#">Figure 3</a> . Production Rev D Devices on or after week 18 of 2006. LQFP80 and LQFP128 packages. Date code format = YMM.

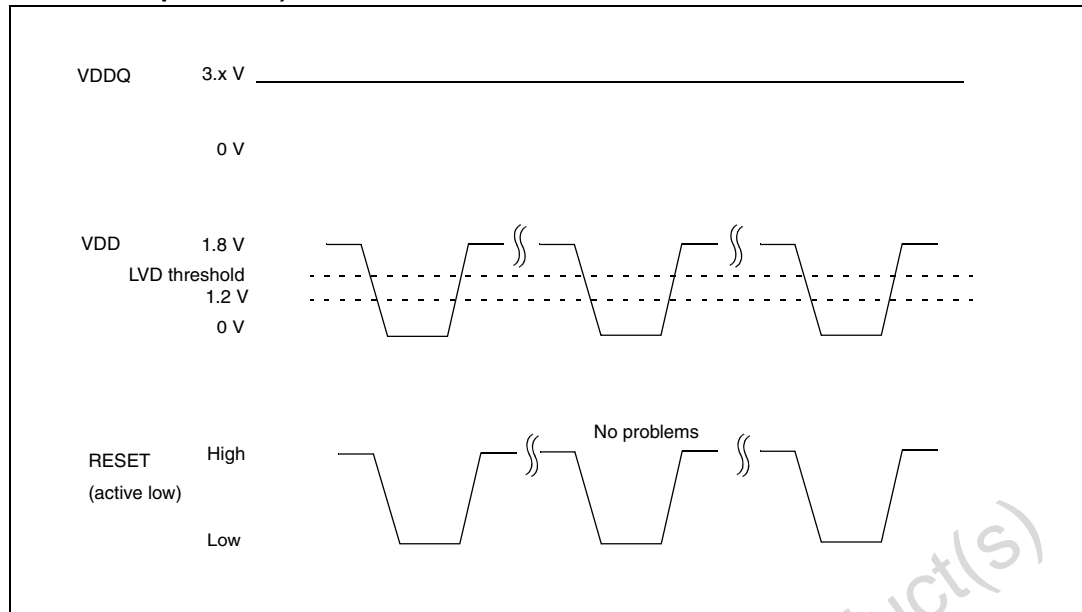
**Figure 6. VDDQ steady, VDD falls below its LVD threshold, and below 1.2 V (no problems)**

*Figure 6* illustrates the third case, when VDDQ is steady, but VDD falls below its LVD level, and falls below 1.2 V. In this case, there is no problem, the generated reset signal will activate and deactivate appropriately (will not get stuck).
