Mode transition blocking by internal IPs clock busy signal

This document presents a possible mode transition stuck in mode entry module (MC_ME) for SPC58xx devices.

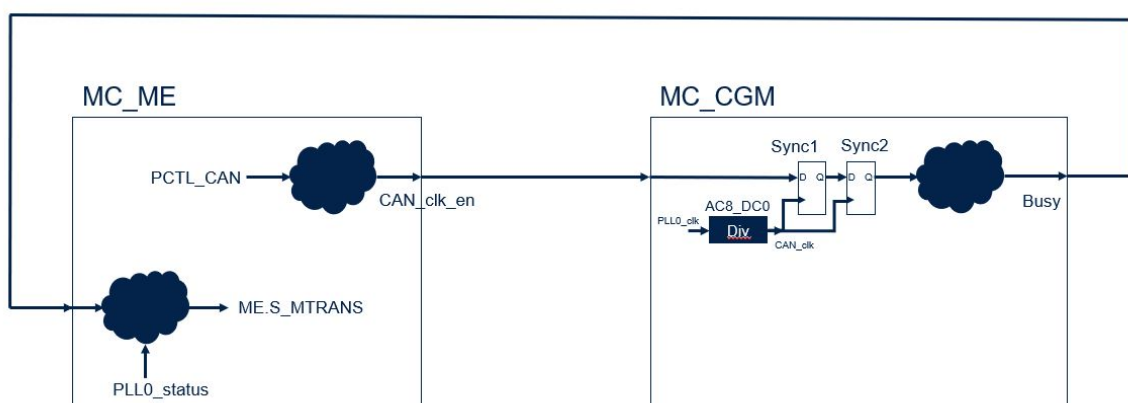
Figure 2. Block diagram when performing a transition

The following figure shows the block diagram of interconnection between mode entry (MC_ME) and clock generation module (MC_CGM) that are involved in completing a mode transition. PLL0 drives auxiliary AC8 clock divider here.

1. PCTL_CAN: for enabling/disabling the peripheral.
2. CAN_clk_en: this is the signal used for evaluating if the peripheral is enabled or disabled.
3. MC_CGM.AC8_DC0: the auxiliary clock divider is used for configuring the peripheral, driven by PLL0:PHI.
4. PLL0_status: this is the signal used for evaluating if the PLL0 is switched on or off.
5. MC_ME.S_MTRANS: this is the mode transition status bit.
