SPC56EL60xx/RPC56EL60xx/SPC56xL70xx/RPC56xL70xx
device exception handling

Introduction

This document provides an overview of SPC56EL60xx/RPC56EL60xx/SPC56xL70xx/RPC56xL70xx exception handling with a main focus on different kind of exceptions that the application code can face during the runtime like Flash 2b ECC error, RAM 2b ECC error, MPU protection violation, AIPS access protection violation and others.

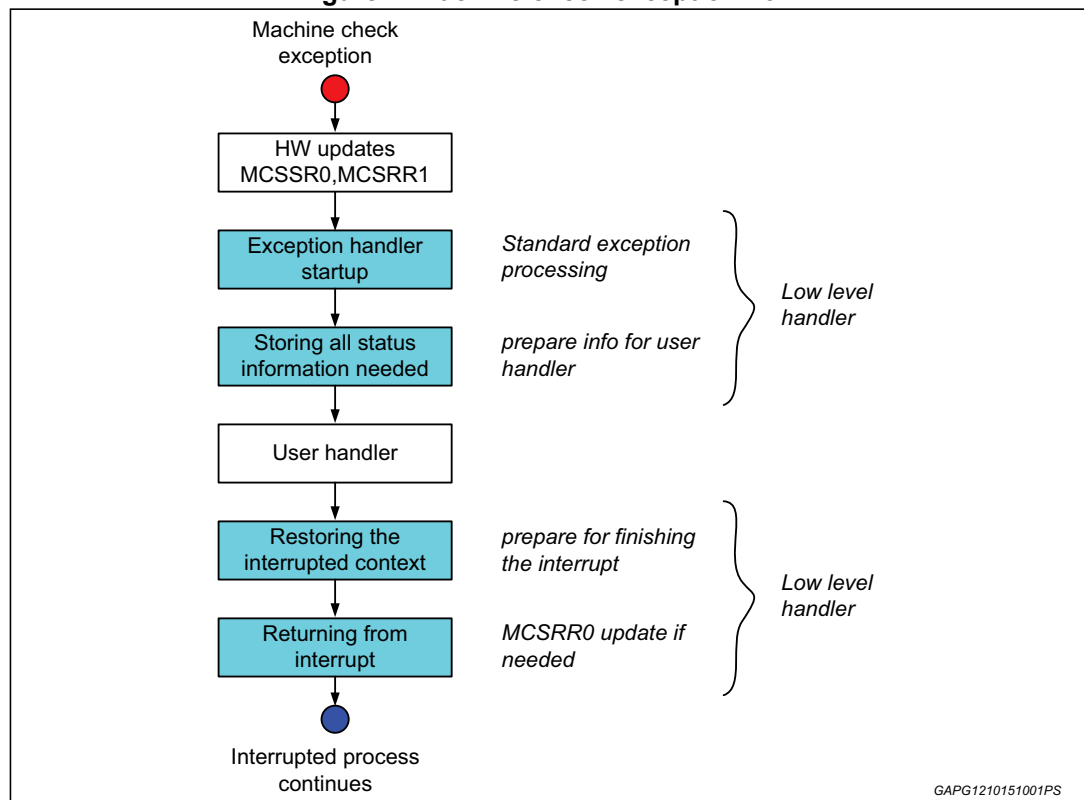
Figure 1. Machine check exception flow

The middle of the interrupt service routine belongs to the user handler where analysis of the root cause of the exception and fault removal is done.

Once the user handler has finished code execution is given back to the low level driver to finish the interrupt and return back to the interrupted process.

The first steps when a machine check exception occurs are done by the hardware (Core) which stores the content of the MSR register and the address of the current instruction pointer whenever it is possible (precise exception).

Low level driver immediately starts processing after. It executes several steps like machine check status register saving, context of the interrupted process saving and others. This part should store some additional information too as it will be used by higher layer user handler to analyze the root cause of the exception later.

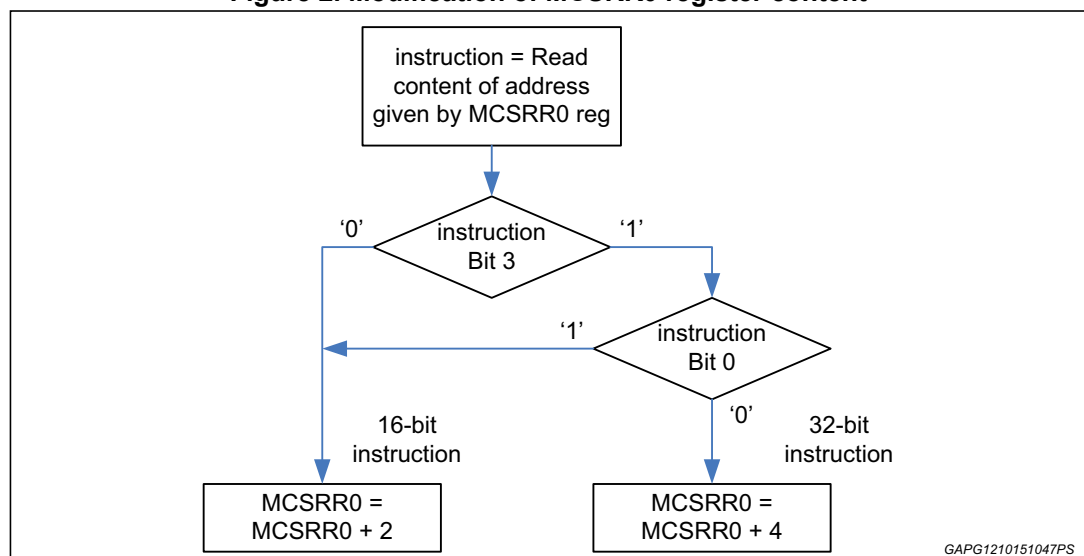
Figure 2. Modification of MCSRR0 register content

In case the cause of the exception cannot be removed, MCSRR0 register value has to be modified in a way that it takes the address of the following instruction. This prevents re-execution of the faulty instruction and retriggering the machine check exception.

Modification has to consider VLE instruction coding in case the interrupted process is implemented in VLE coding and increment the value according to the length of the faulty instruction pointed by the current MCSRR0 register content, see [Figure 2](#).

It is used in the end of the machine check when *mcrfi* instruction is executed to fill the instruction pointer. The result is that code restarts the same instruction that was the cause of the error, if additional modification of the MCSRR0 register is not explicitly done.

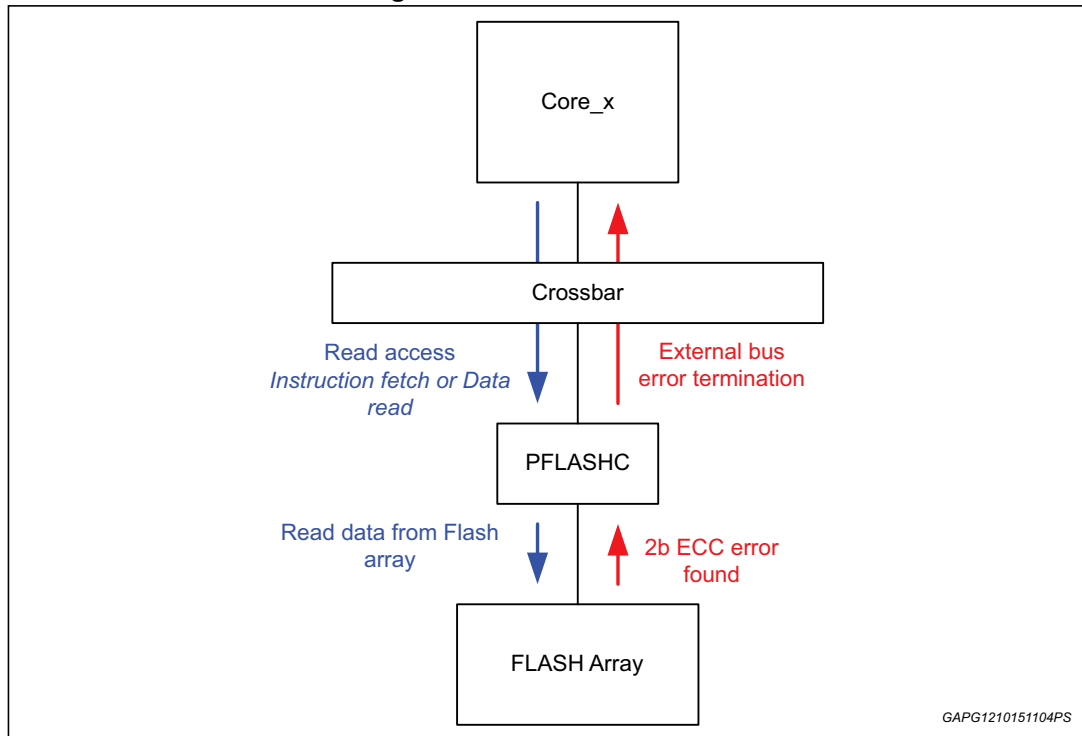
Figure 4. Flash 2b ECC error

Platform flash memory controller (PFLASHC) terminates bus transaction between CPU and PFLASHC controller in case the Flash memory array signals 2b ECC problem during read access. This leads to machine check exception because of *bus_error* termination.
