Introduction

This document describes the updater functionality of BlueNRG and BlueNRG-MS devices.

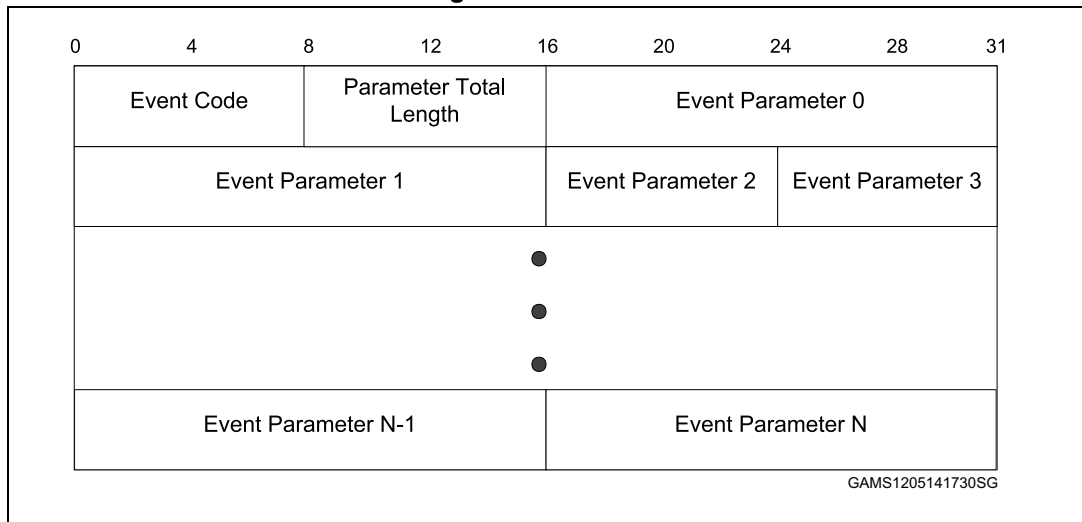
Figure 3. ACI event

The Evt_Blue_Initialized event is an ACI event with the same format as the other events.

It is a vendor specific HCI event (event code 0xFF). In [Table 1](#) all the fields are described.
